**G. GRAY &
ASSOCIATES LTD.**

RE: DWELLINGHOUSE AT TULLYNASCREEN, DROMAHAIR, CO. LEITRIM.

We refer to the above and to instructions received to carry out an inspection of the dwelling with a view to providing a Report on its condition for the purposes of applying for a Grant for the refurbishment of the dwelling. Further to attending at the property on the 18th September 2025 and having carried out our inspection we set out hereunder details of our findings:-

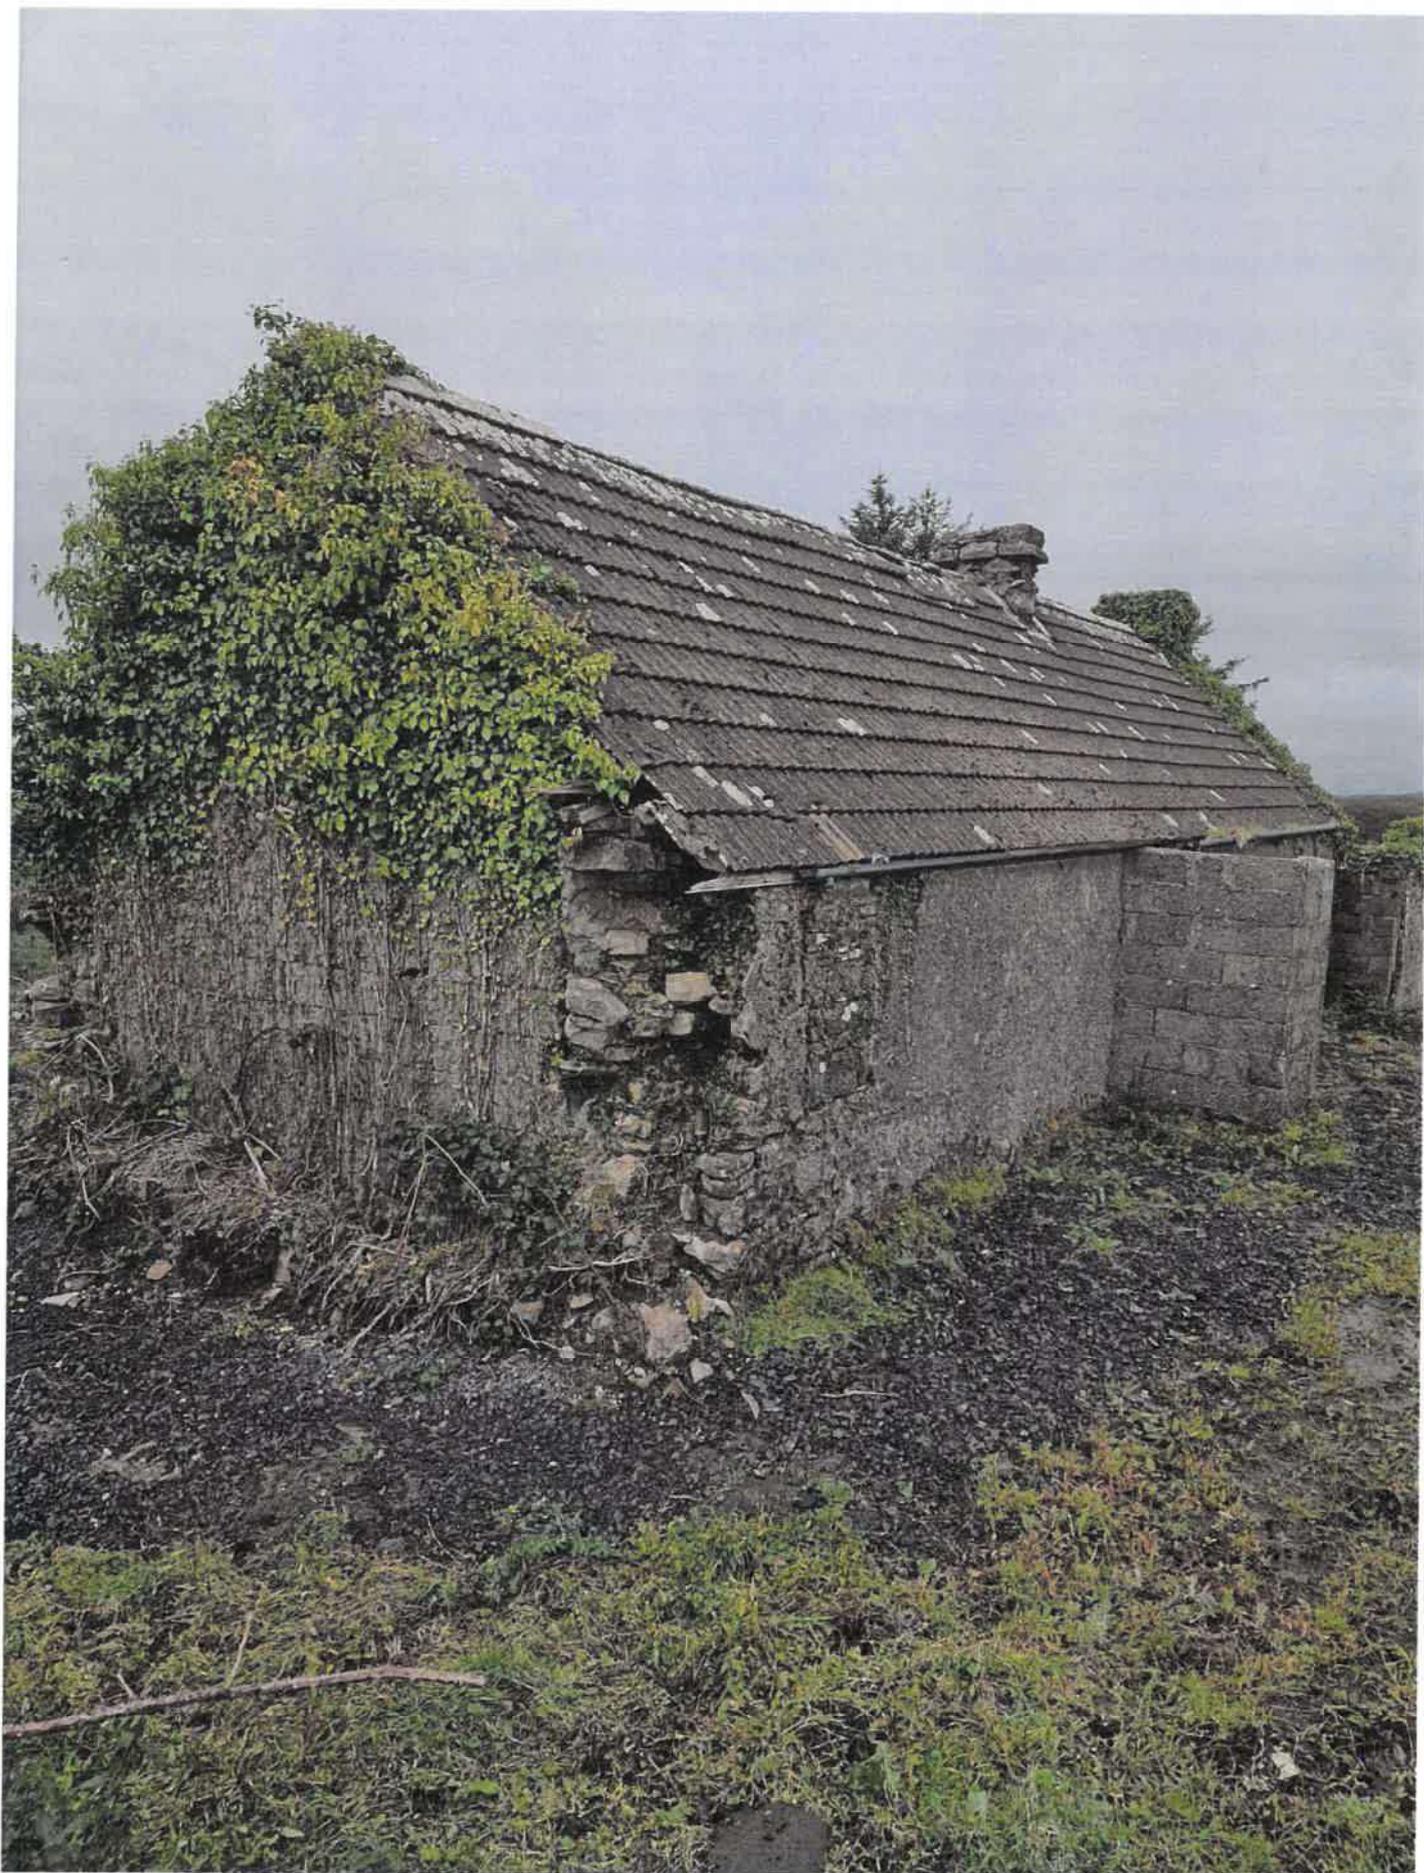
where the render has fallen off. The block gable on the right-hand side isn't rendered and is not properly pointed and appears to have been a temporary measure. Windowsills are concrete and are in very poor condition. There is extensive ivy growth on both gables and along parts of the front of the dwelling. The ivy has penetrated the dwelling in all locations and poses a risk to the property structurally. The ivy needs to be cut back and killed off to ascertain the condition of the stonework at these locations. The heads over the windows and external doors appear to be timber and there is structural cracking visible over the heads of some of the windows and doors. Based on what we could see externally the ivy has likely caused additional structural damage to the stonework, which leaves it structurally unsound and dangerous. Where the ivy has penetrated through the stonework the walls will need to be taken down and rebuilt. The exposed walls at the gable where the blockwork is located will also need to be stripped back and rebuilt where water has penetrated the stonework due to it being exposed to the elements for a long period of time. The heads over all the windows and doors will need to be replaced and the walls rebuilt in these areas where there is structural movement. The foundations for the property are exposed on the right-hand gable and consist solely of stones placed on the subsoil. It will be necessary to carry out underpinning works to the external walls to provide a suitable foundation. Sections of external wall, where there is structural cracking, will need to be taken down and rebuilt. The same will apply where there is extensive water penetration into the wall due to the render having fallen off. There is no insulation or damp-proof courses in the external walls and both items will need to be addressed as part of refurbishment works. It is likely that an in-situ concrete ring beam will need to be provided at wall plate level to help tie the dwelling together and in summary the upgrade works to the walls will include, but not be limited to, underpinning the sections of walls that will be retained, rebuilding extensive sections of external walls including one entire gable, new concrete sills and lintils at all window and door openings, installation of damp proof courses and provision of insulation to the external walls, rendering the walls externally and internally and removal of ivy.

Photograph no. 3 Shows the right-hand side gable, which is rebuilt in blockwork, is not rendered and covered in ivy.

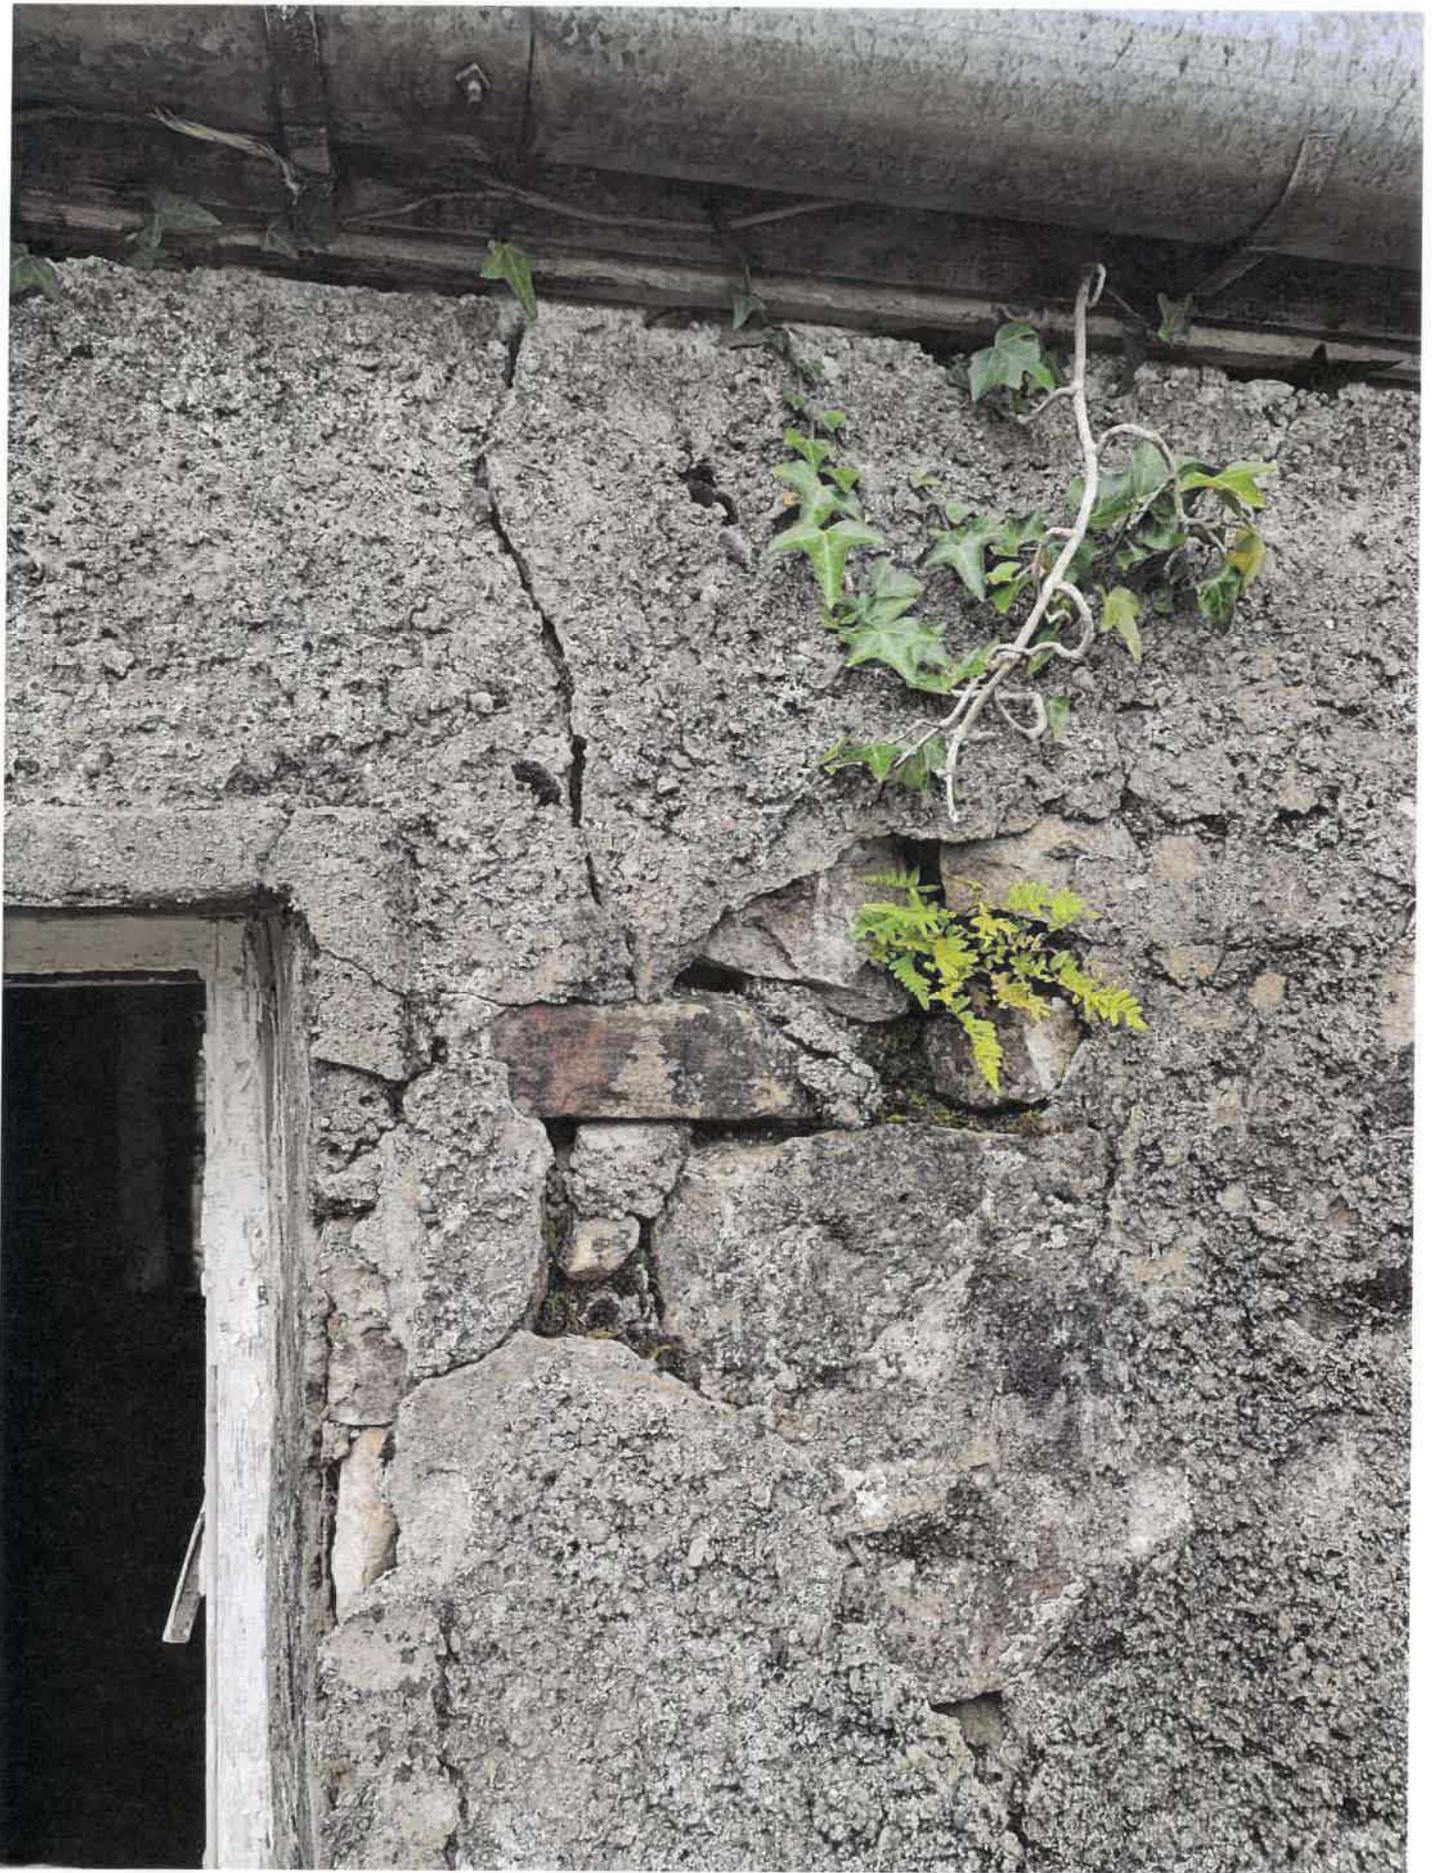
Photograph no. 4 Structural cracking in the external wall at one of the window openings.

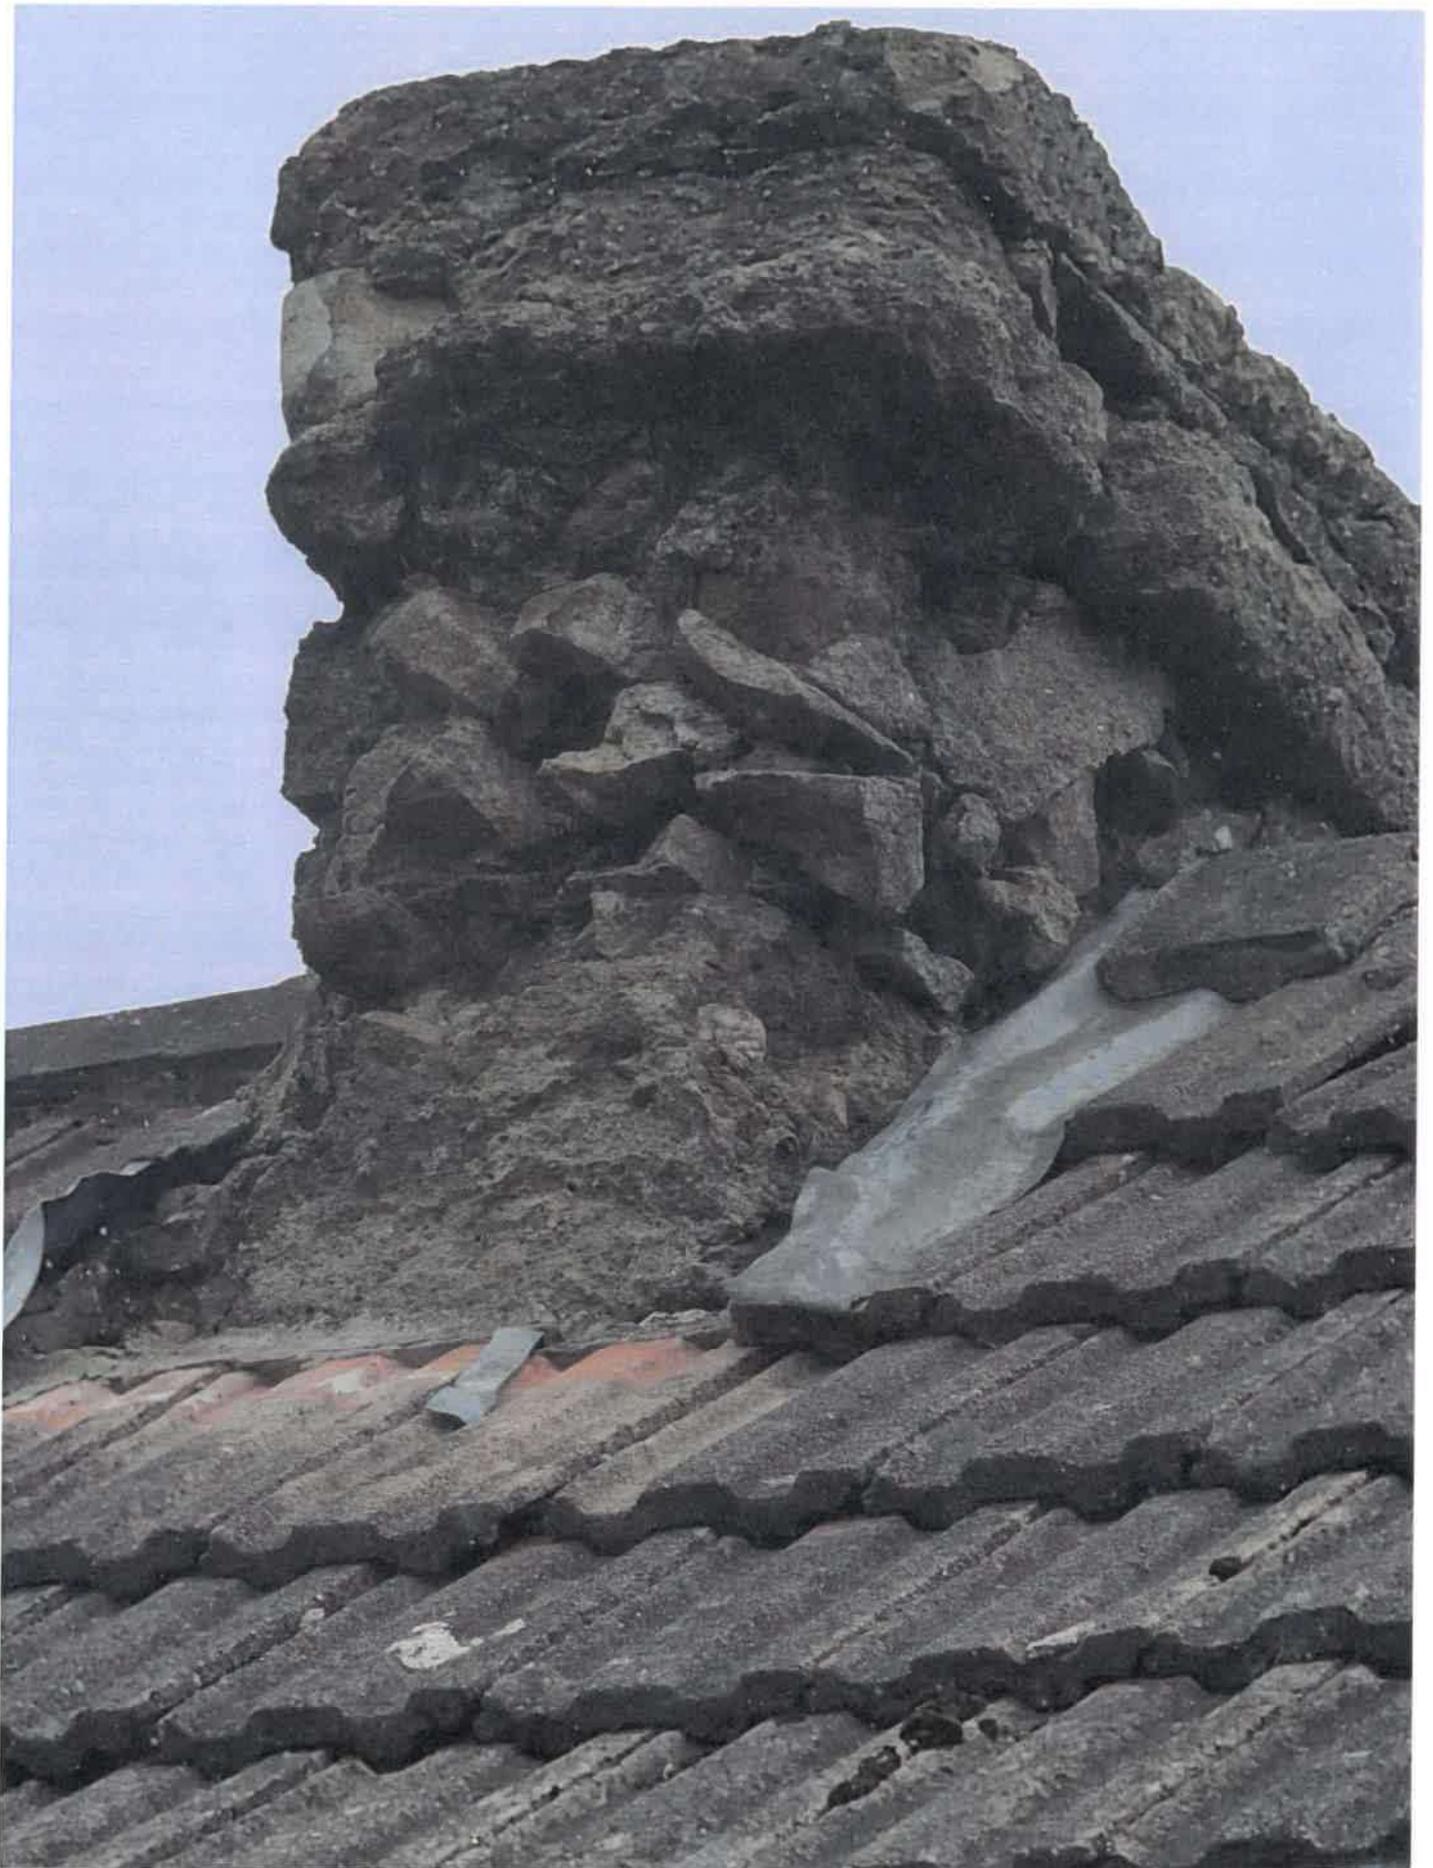
Photograph no. 5 Close-up view of one of the chimneys, which is structurally unsound and dangerous.

slates/tiles, new fascia, soffit, gutters and downpipes will also be required. The two chimneys will need to be taken down, and rebuilt if it is planned to keep either of them. We would describe the roof and chimneys in their present condition as structurally unsound and very dangerous.

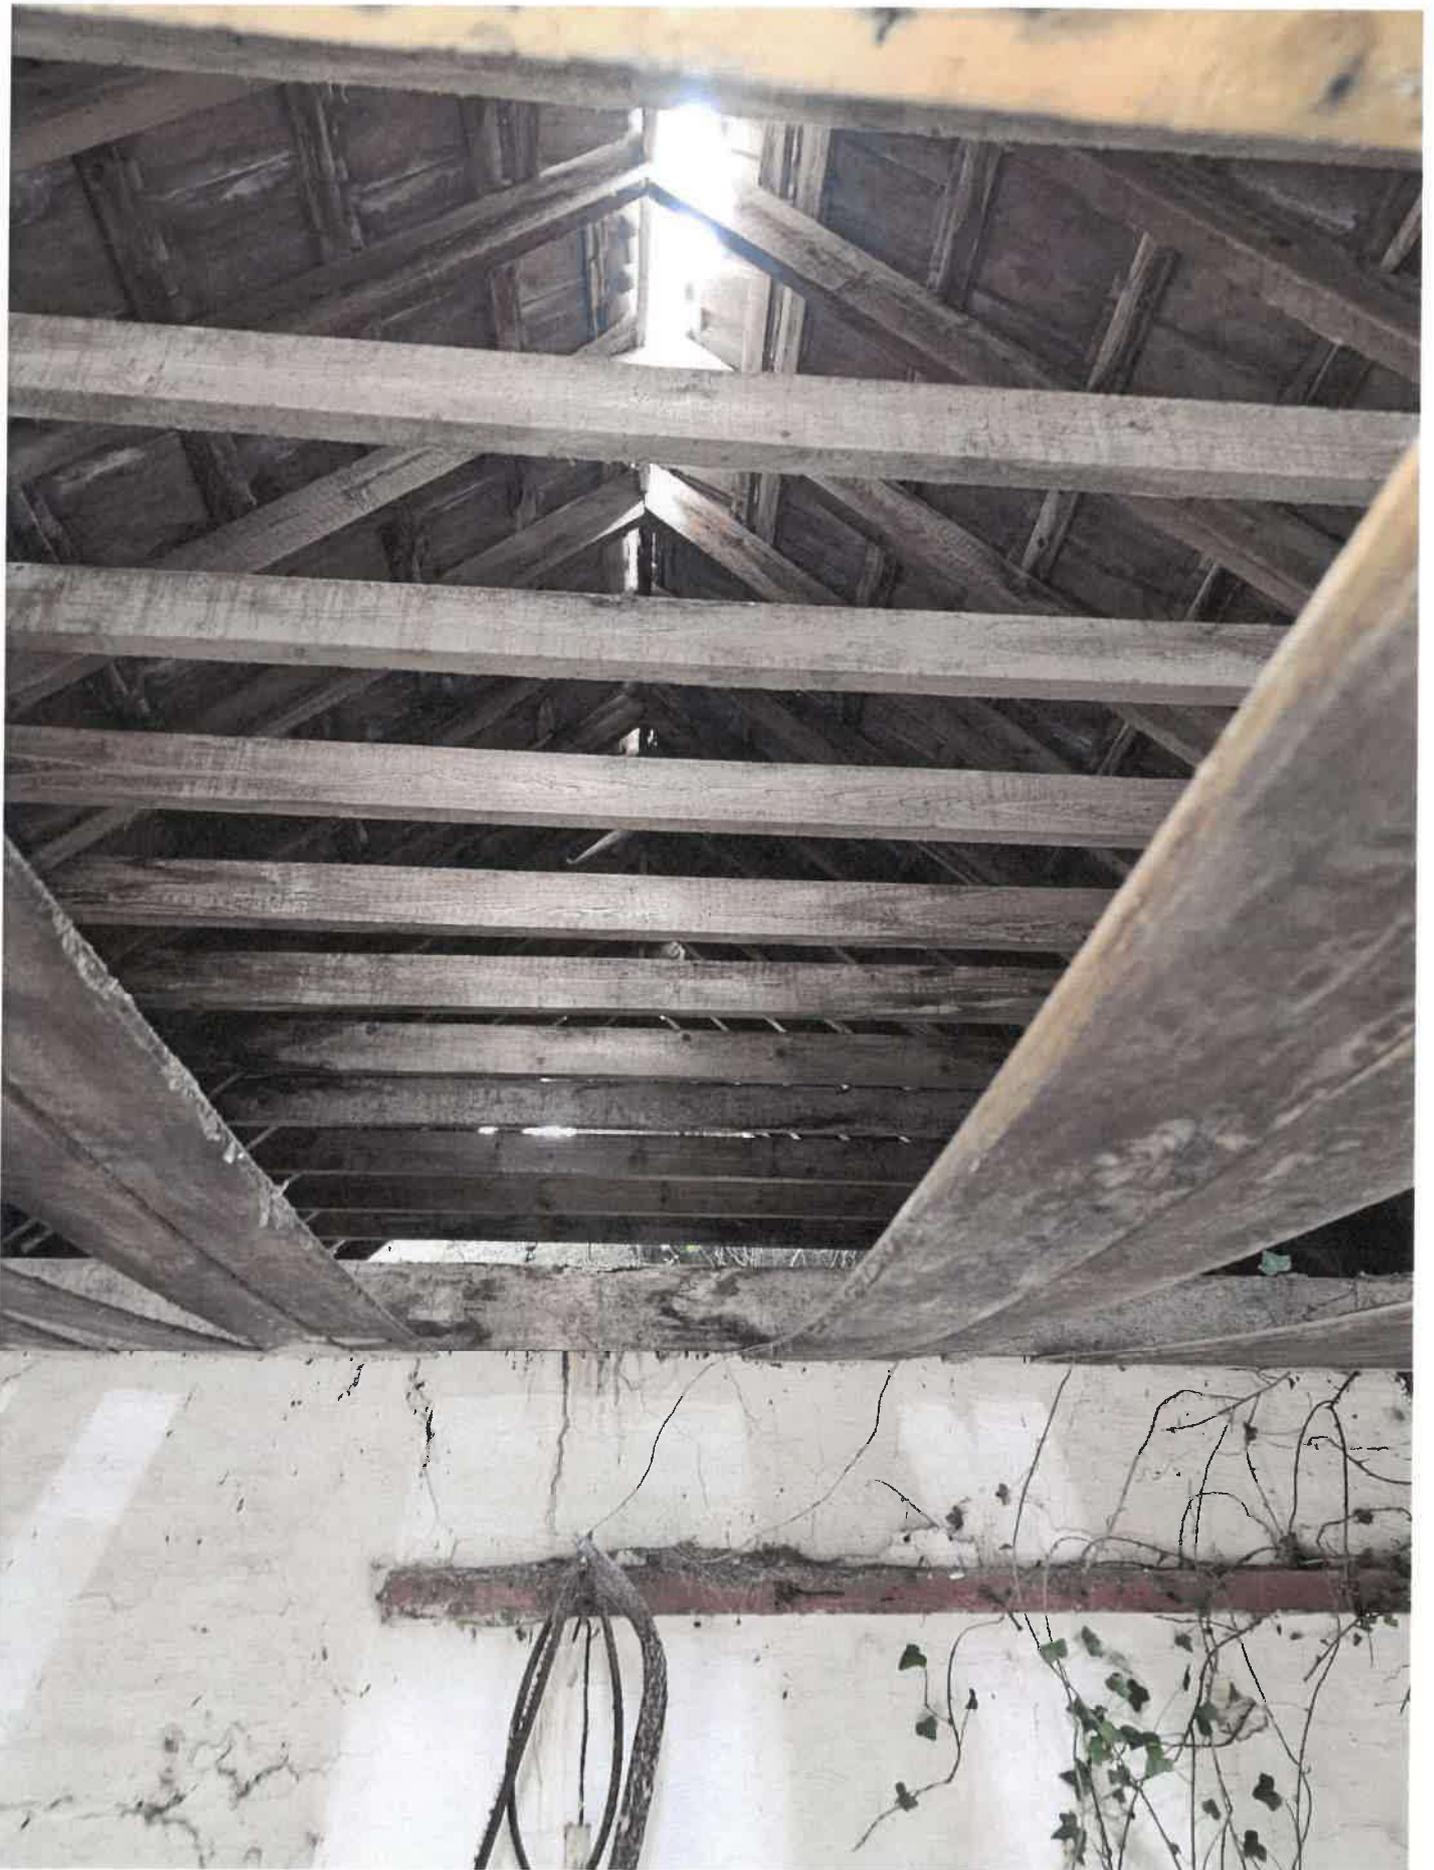
- (i) **Attic space:** As the ceiling has partially collapsed in most rooms it was possible to see the attic area. There appears to be no felt on the underside of the roof. There is extensive rot visible in the roof timbers, although it may be possible to salvage some of them. Presently there is extensive water ingress occurring into the dwelling. Efforts were made with polythene to prevent the water ingress, which is principally occurring as a result of ridge capping and roof tiles blowing off, possibly in the recent storm earlier this year. Attic insulation and ventilation will be required in the new roof.

Photograph no. 6 An internal view of the attic space. Note: daylight visible at ridge level where the ridge capping's and roof tiles are missing.

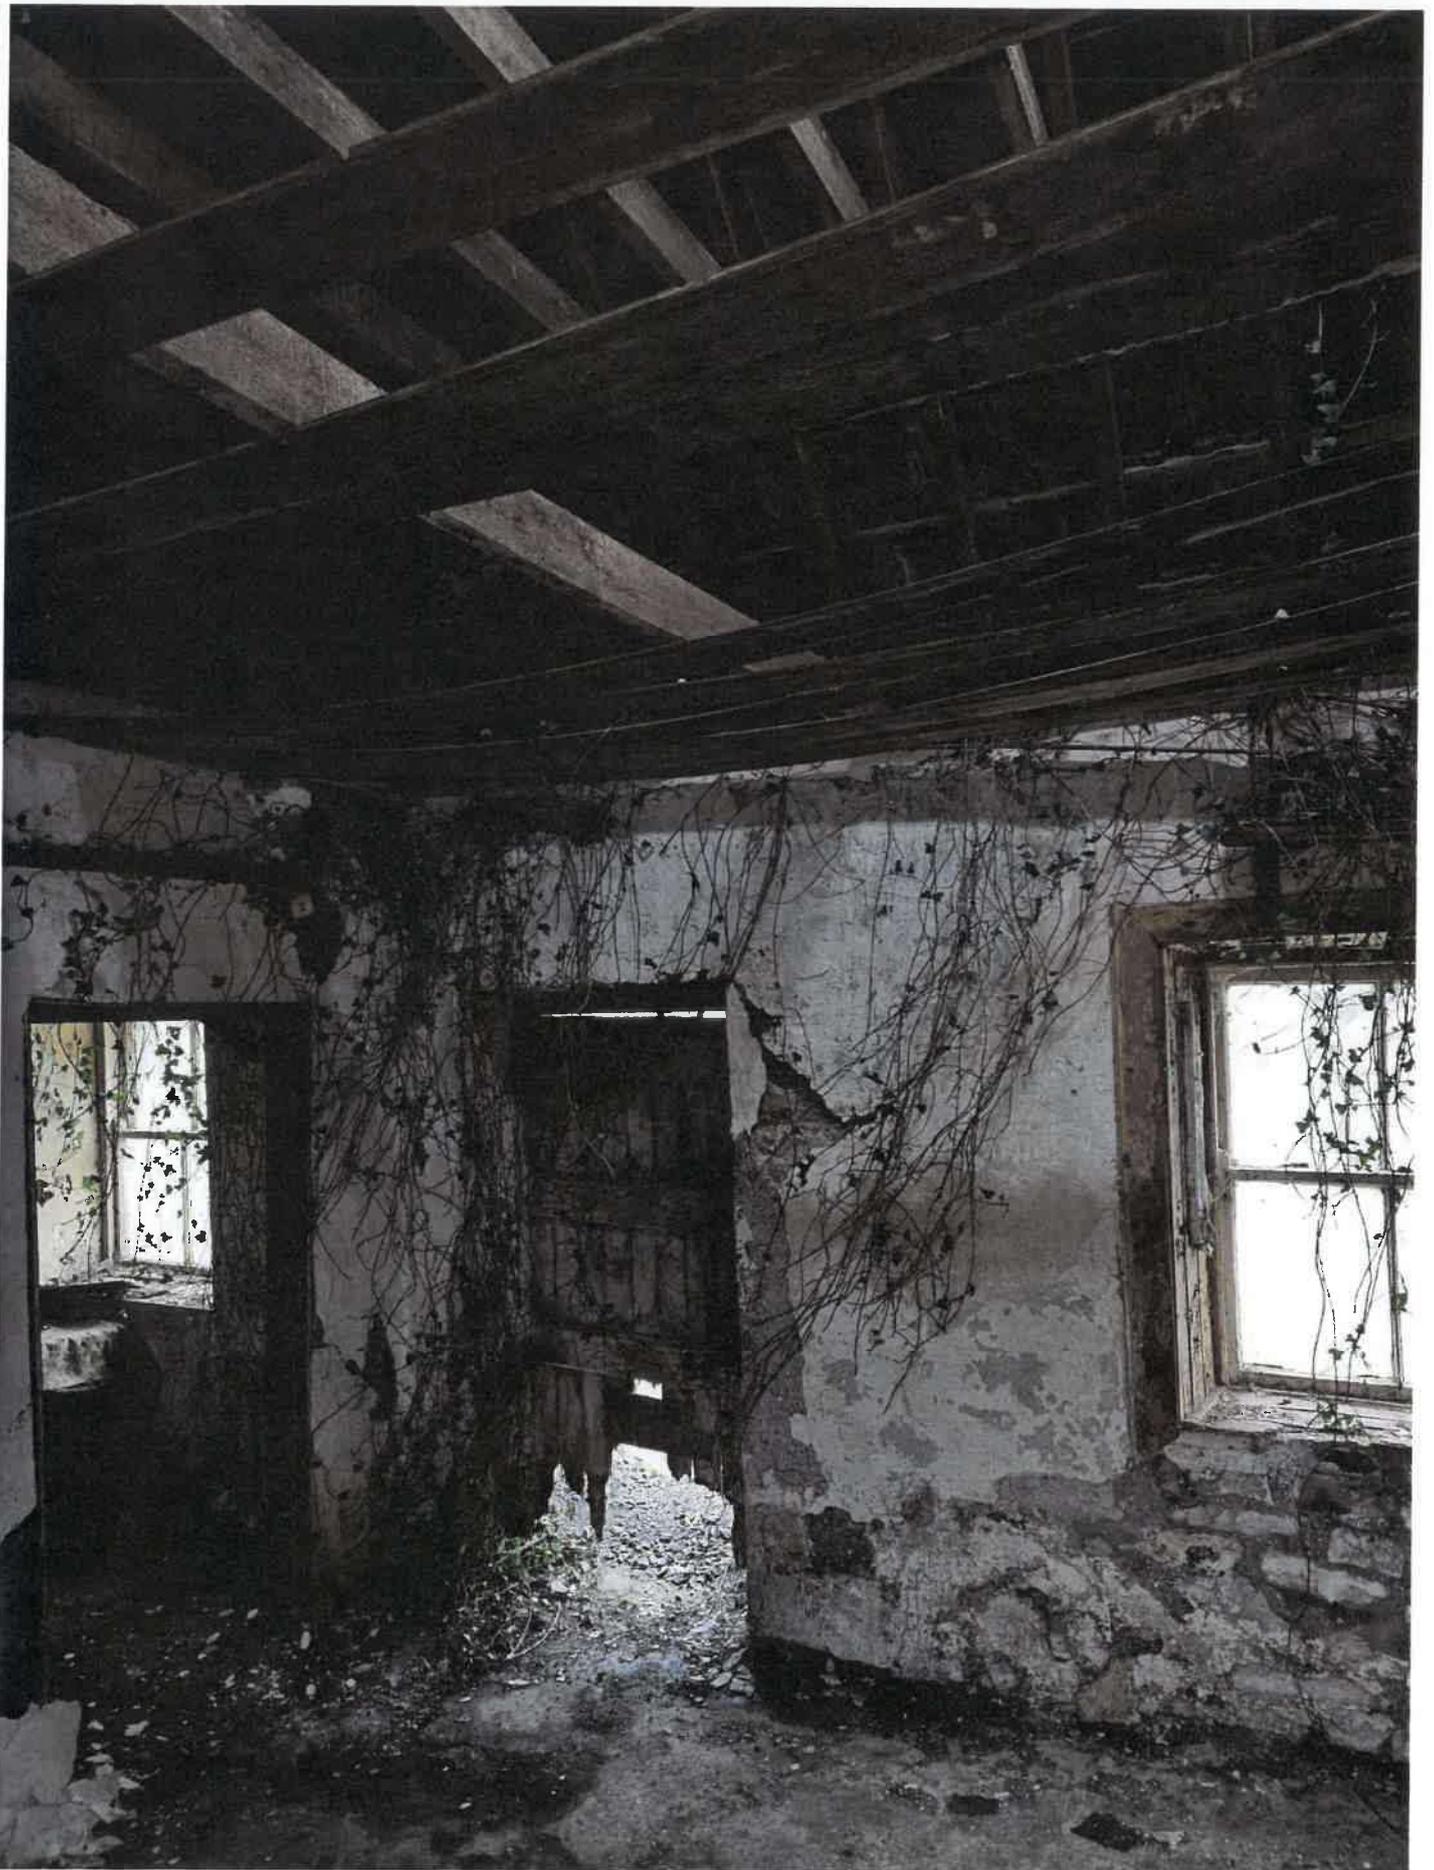
- (c) **Ceilings:** Ceilings in the dwelling were wood sheeted ceilings, most of the ceilings have collapsed due to water ingress occurring through the roof. It will be necessary to provide new ceilings throughout the dwelling.

Photograph no. 8 An internal view in the dwelling, Showing the inside of the front door. The ivy penetration is also visible as well as the collapsed ceiling.

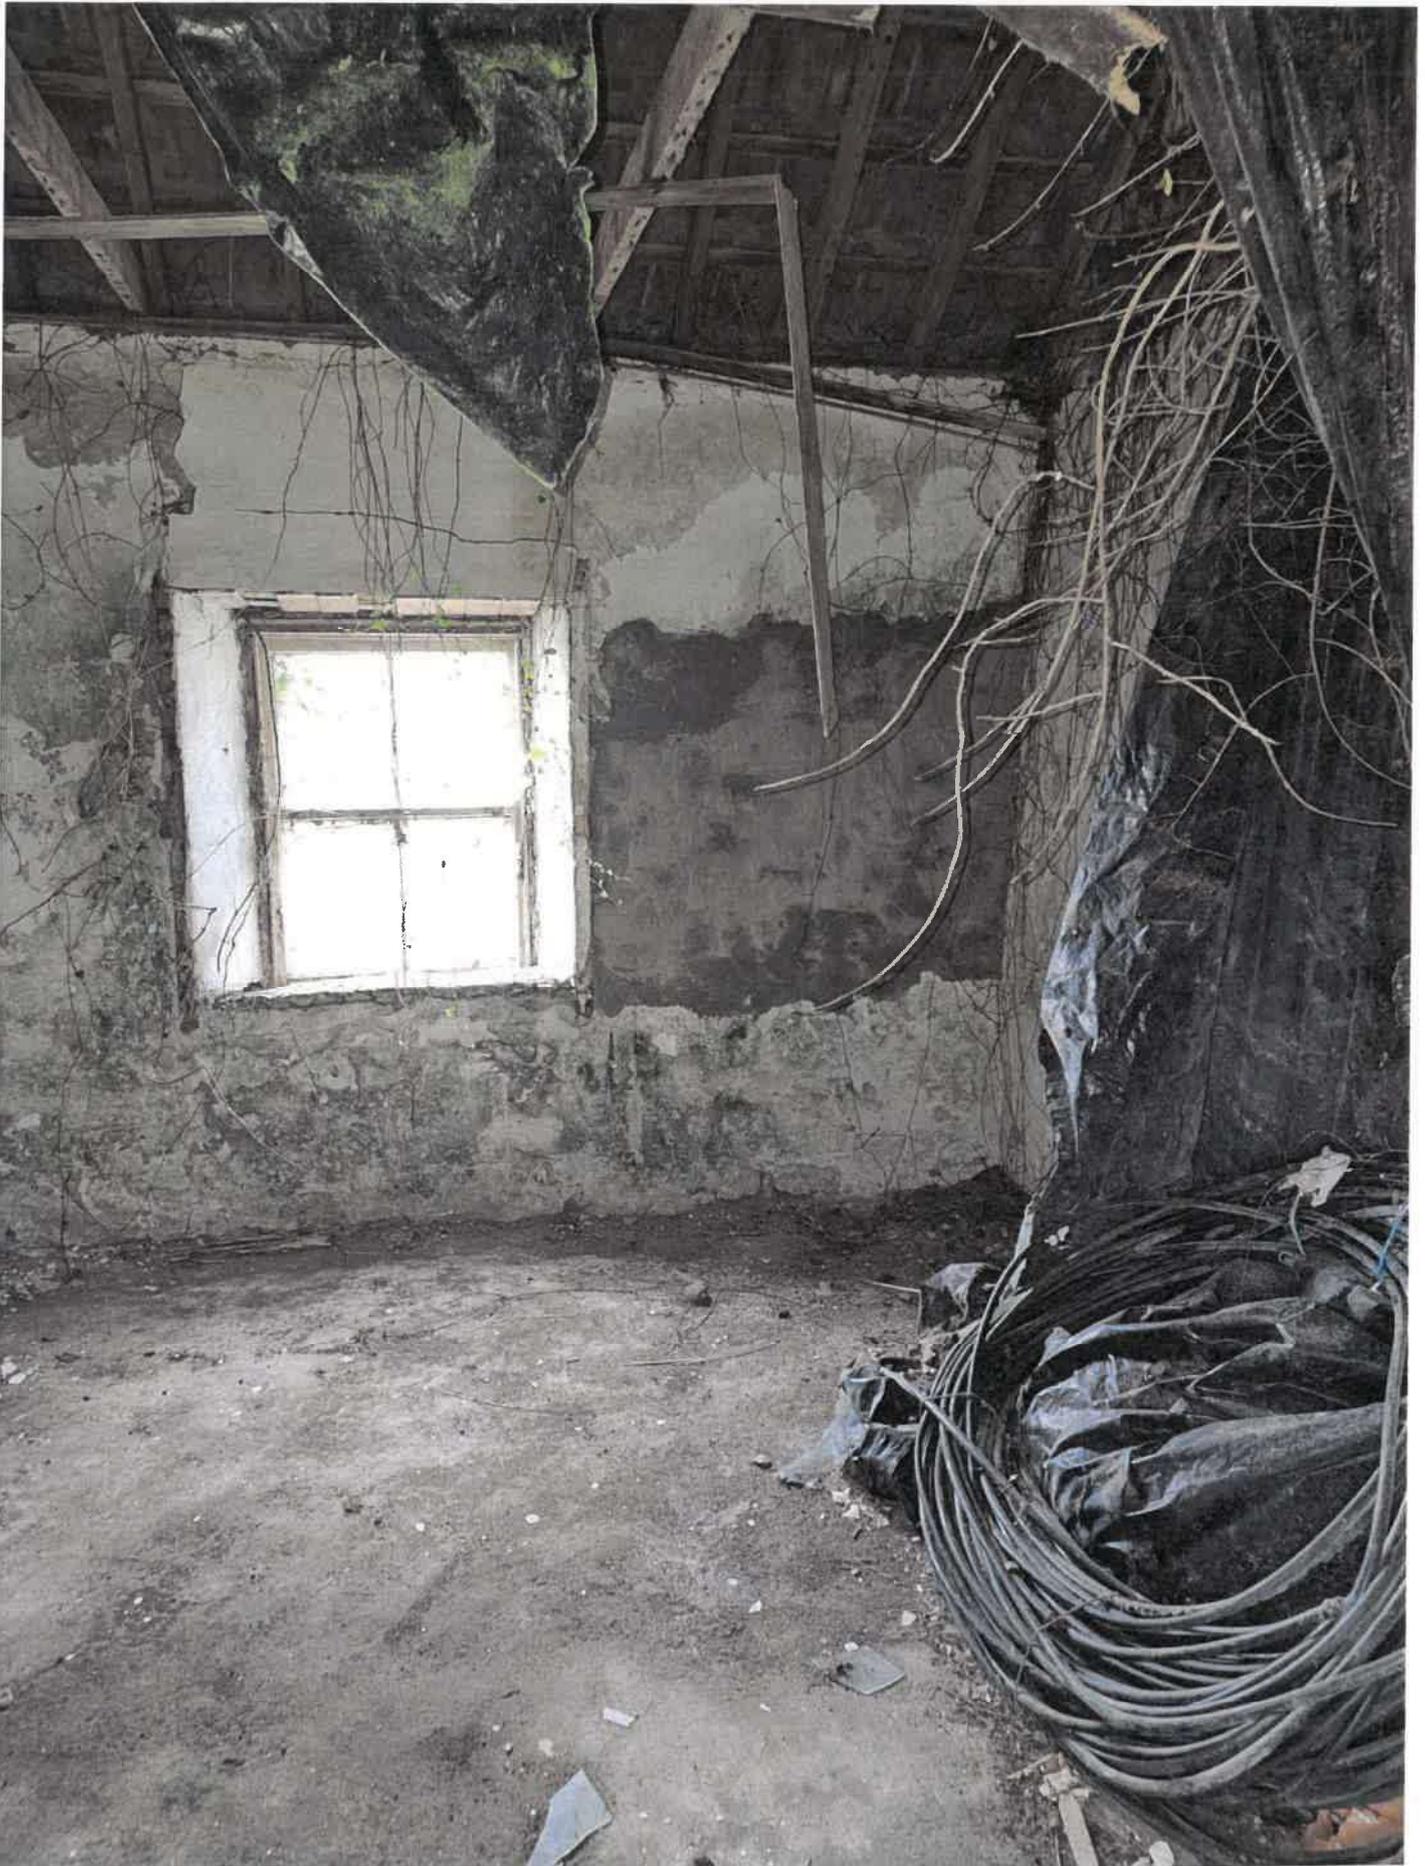
Photograph no. 9 An internal view of the third room, which is on the left-hand side as you look at the front of the dwelling. The polythene used to help prevent rainwater from entering the dwelling is visible.

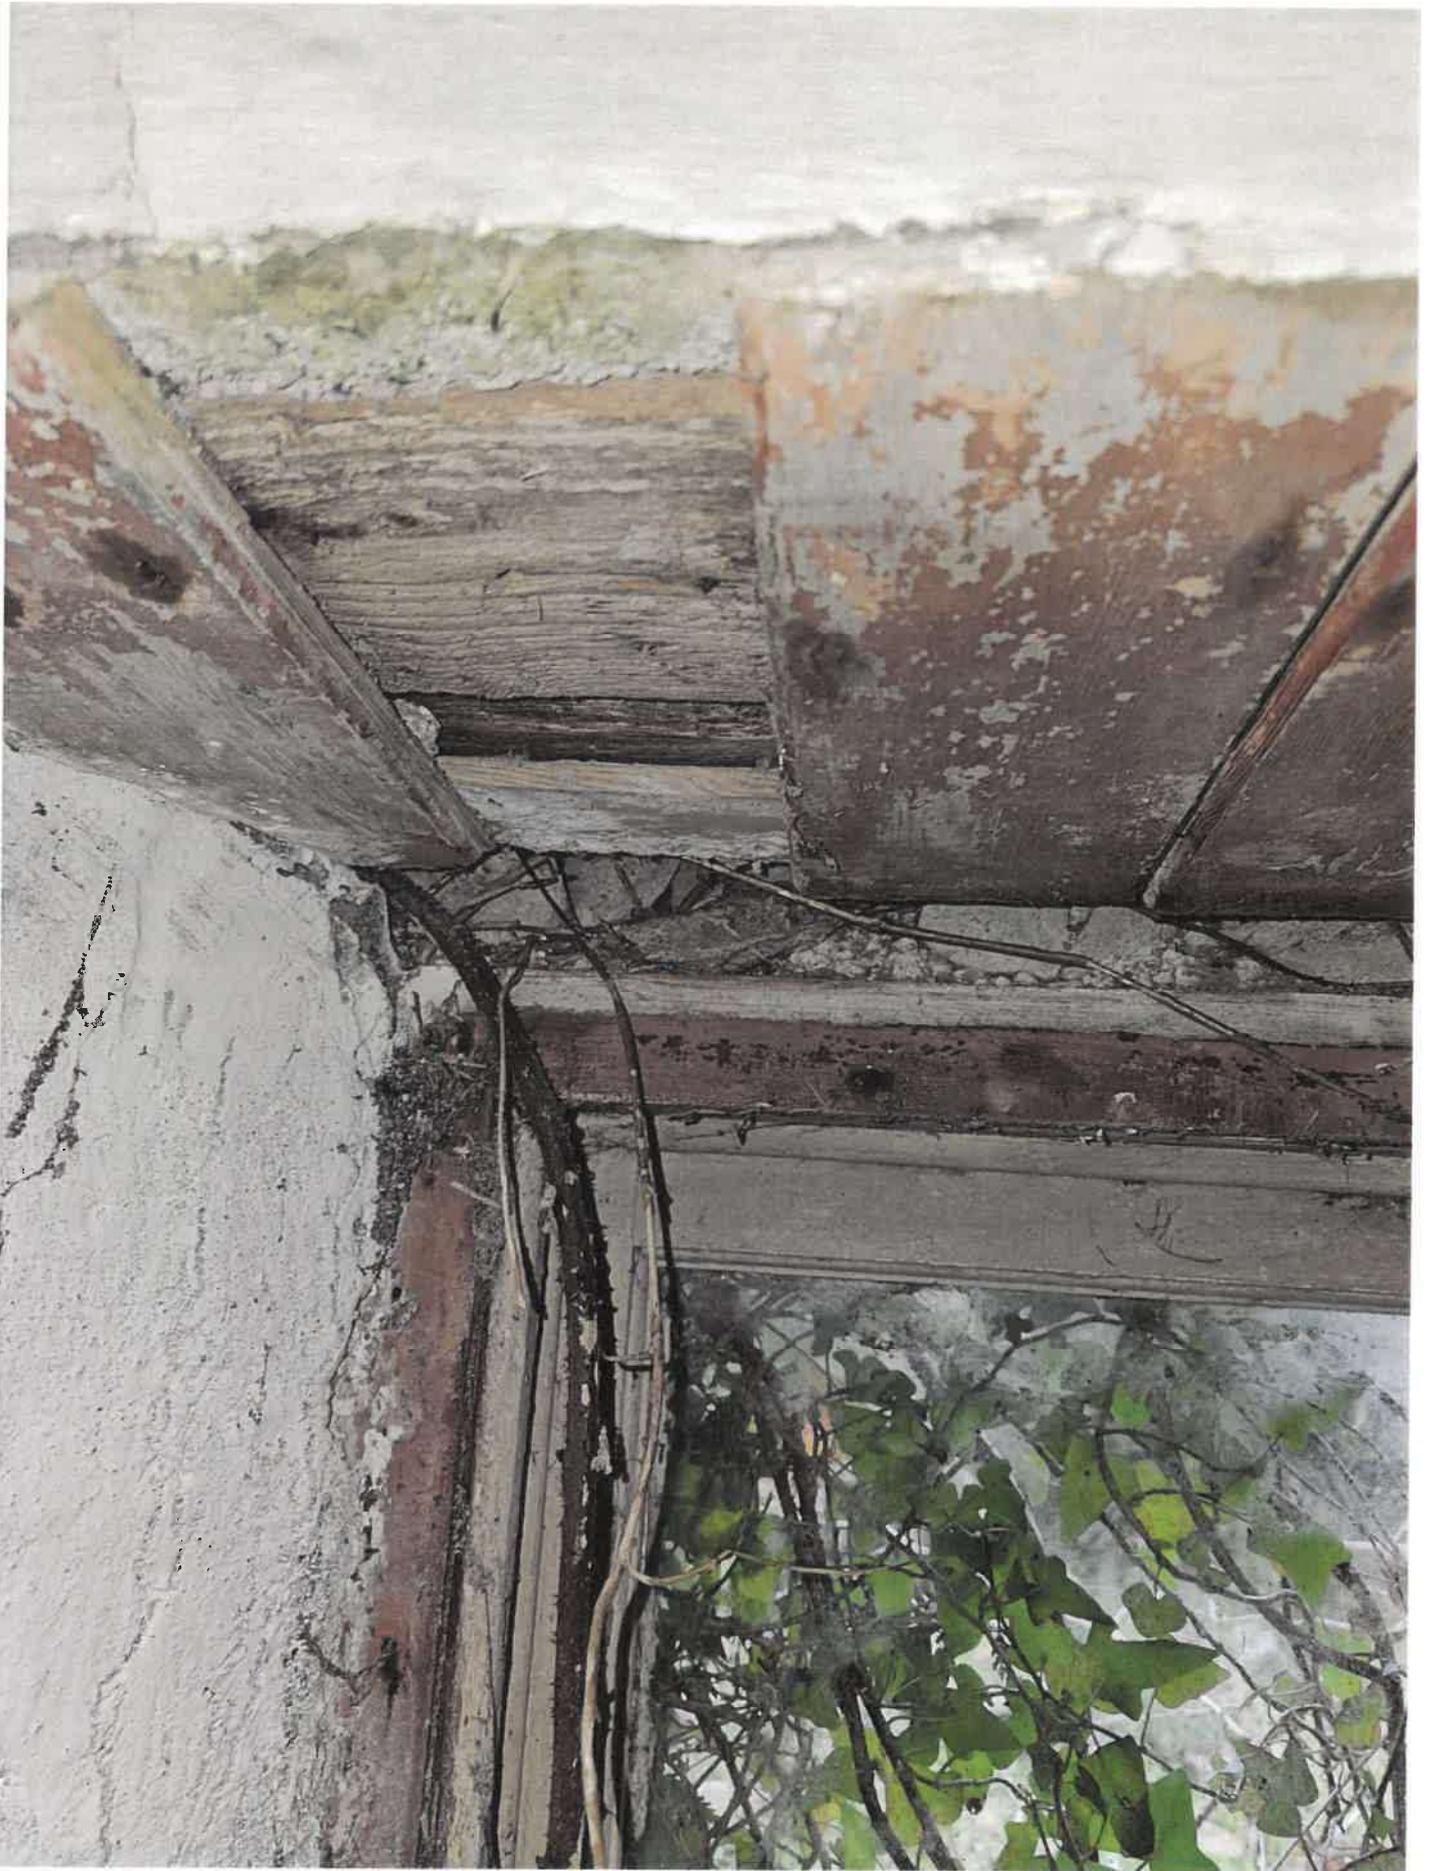
Photograph no. 10 Close-up photo of timber heads over one of the window openings.

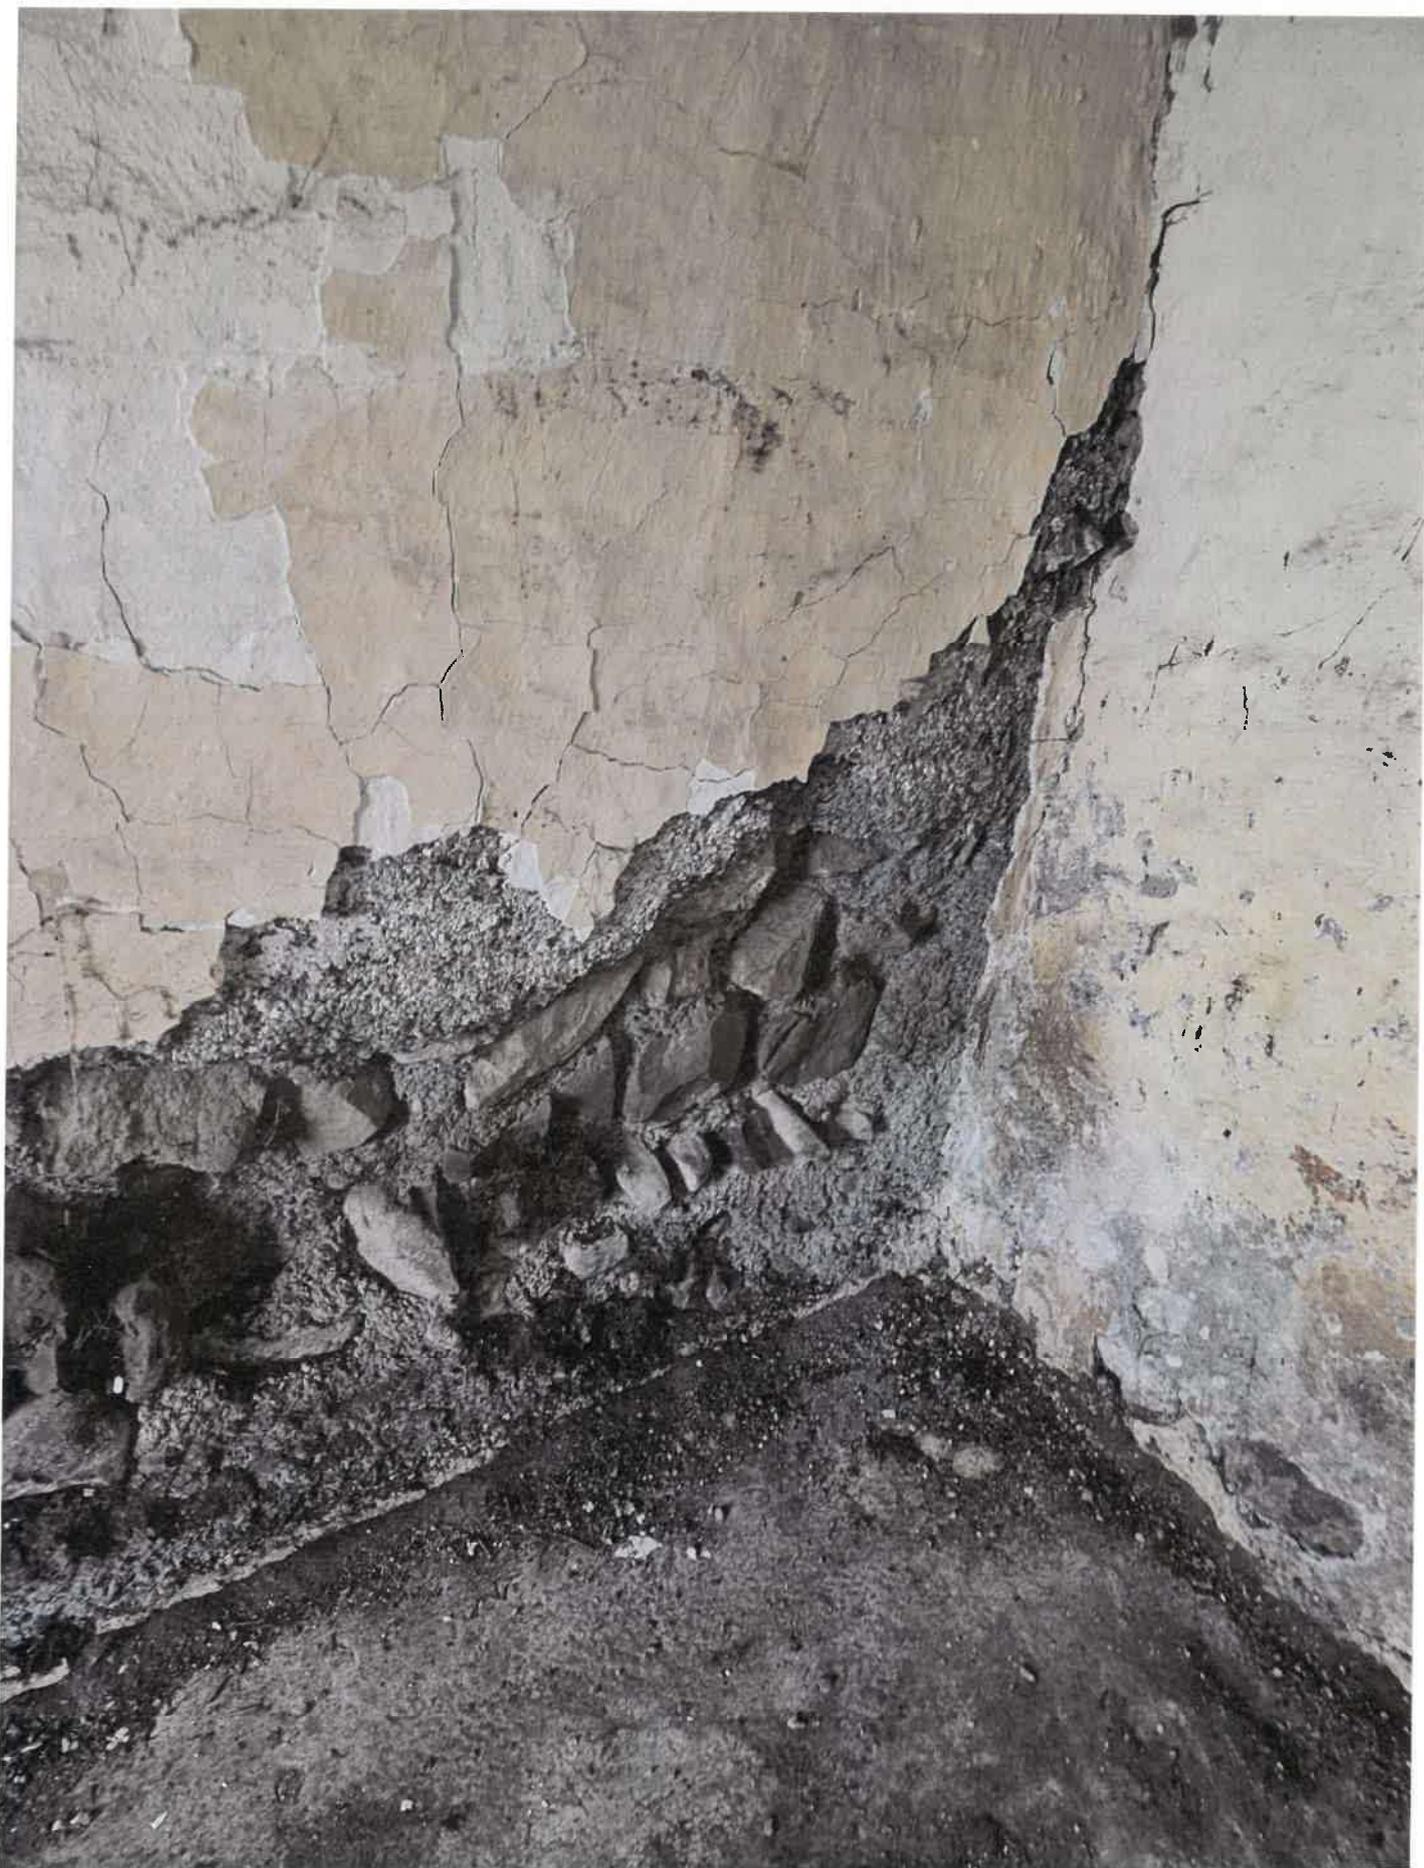
- (b) **Internal Walls:** There are two principal internal walls, one of them contains a chimney breast and can likely be salvaged. There will however be extensive rebuilding works required. The second internal wall is a thinner wall. It is in very poor condition from a structural point of view. We would consider it to be structurally unsound and dangerous. It will need to be demolished and rebuilt.

Photograph no. 11 Shows the internal wall, which needs to be demolished and is structurally unsound and dangerous.
