**G. GRAY &
ASSOCIATES LTD.**

RE: DWELLINGHOUSE AT TULLYNASCREEN, DROMAHAIR, CO. LEITRIM.

We refer to the above and to instructions received to carry out an inspection of the dwelling with a view to providing a Report on its condition for the purposes of applying for a Grant for the refurbishment of the dwelling. Further to attending at the property on the 18th September 2025 and having carried out our inspection we set out hereunder details of our findings:-

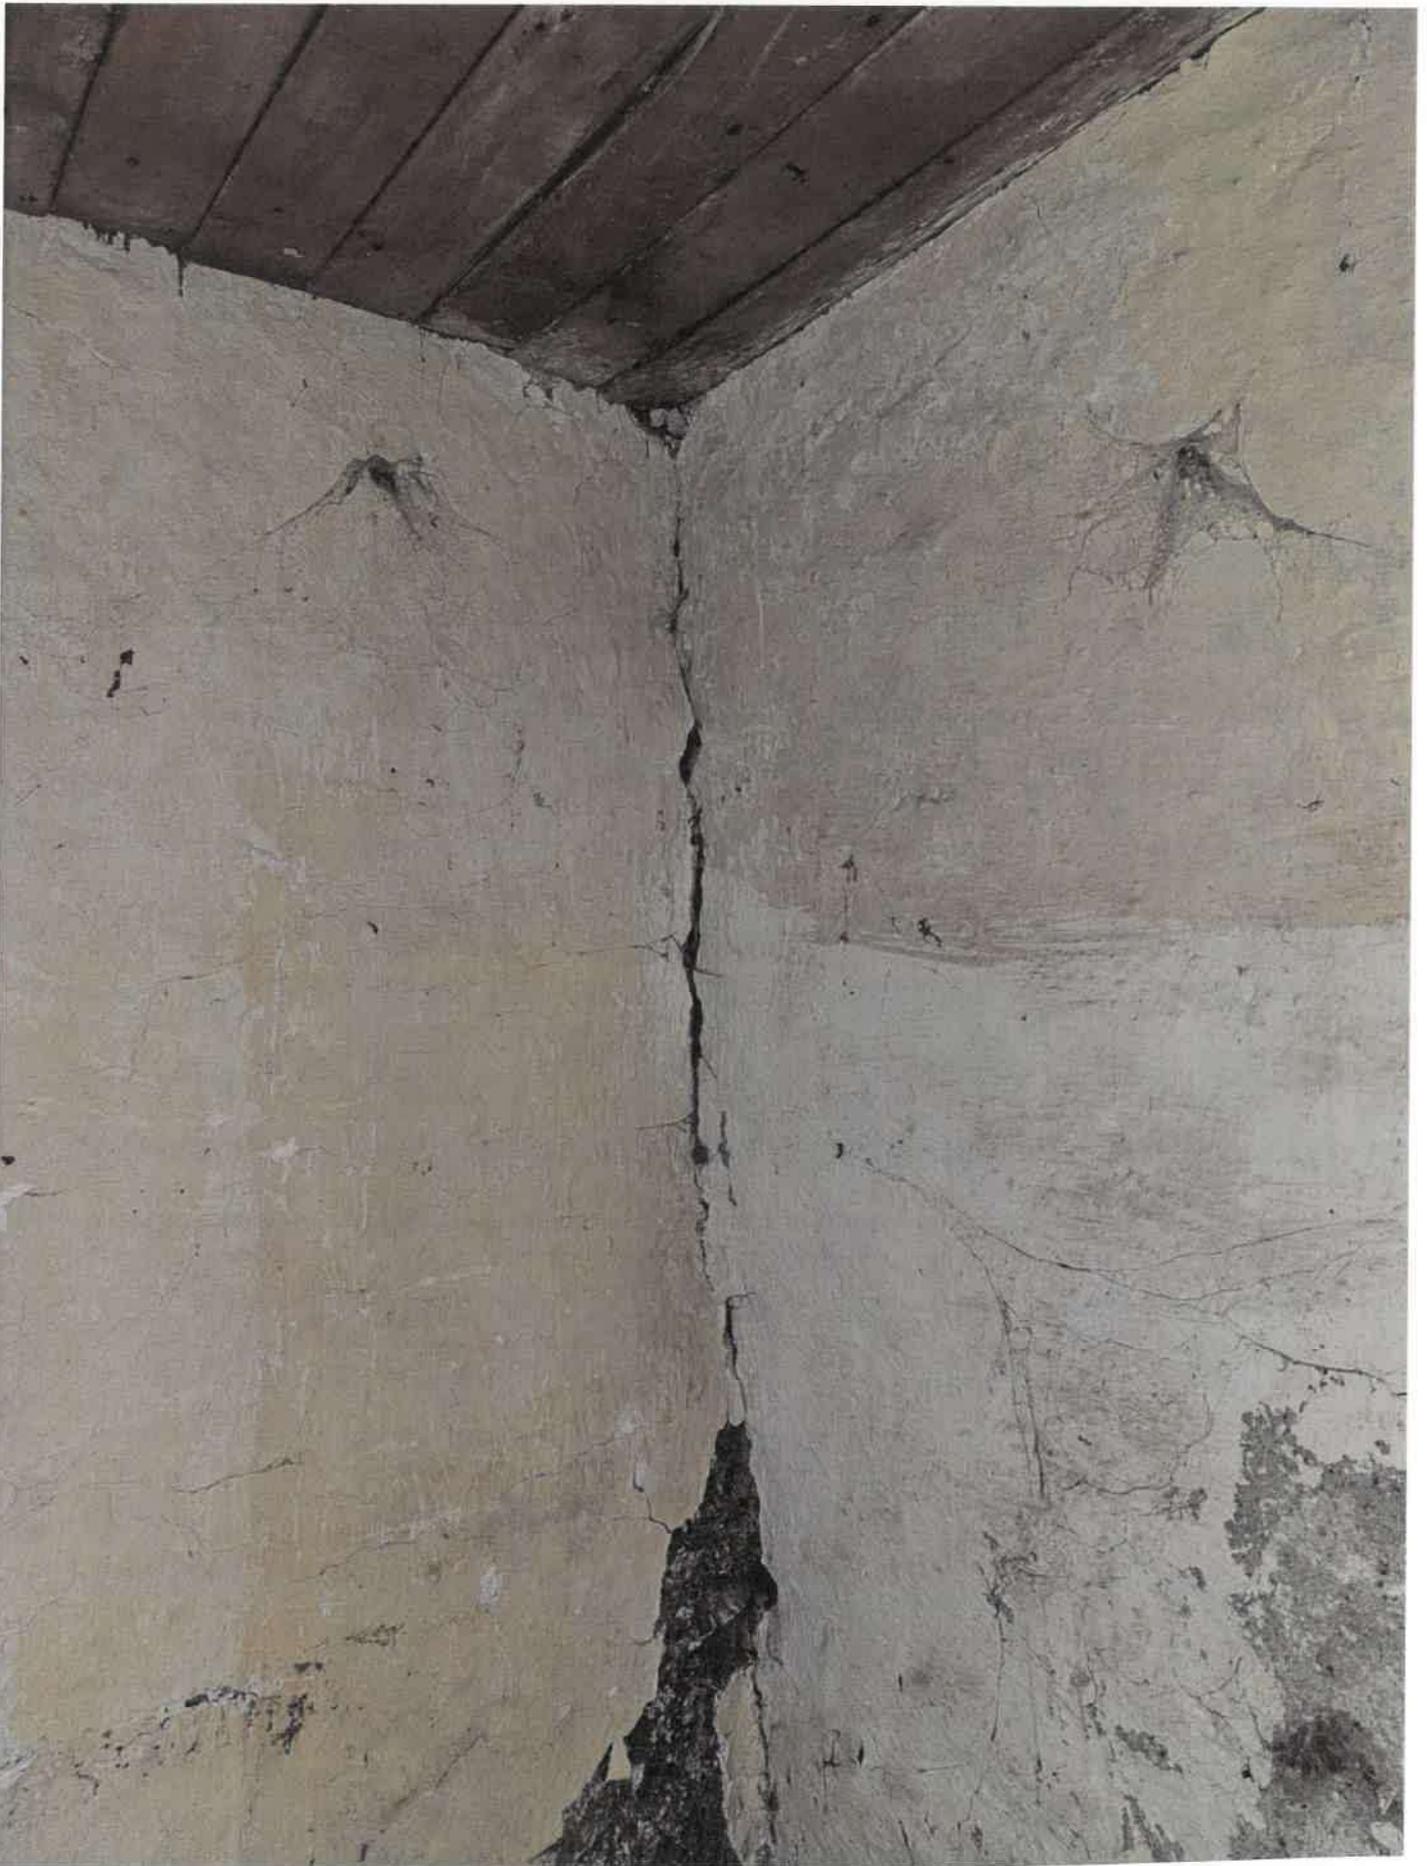
Photograph no. 12 Shows structural movement between the internal wall that needs to be demolished and the external wall.
