**N4 Carrick-on-Shannon to  
Dromod Project**

**Preliminary Sources Study Report**

274219-ARUP-02-OS-RP-CG-000001

P02 | 11 March 2022

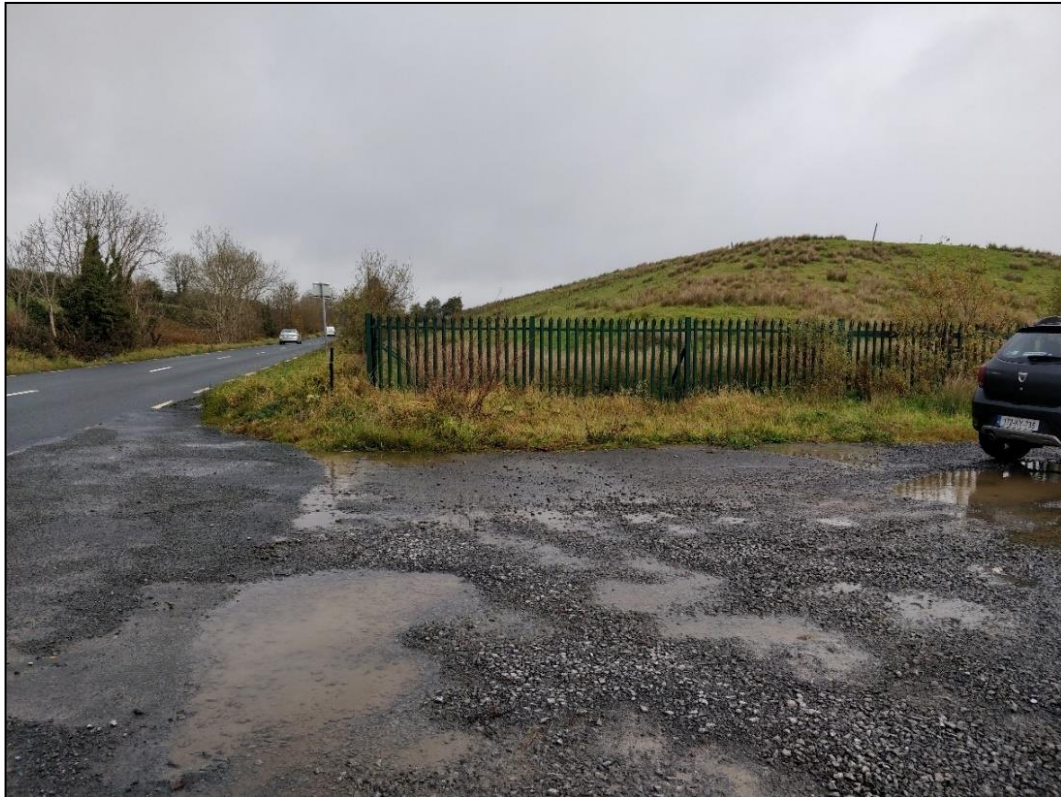
#### L1.1 Looking North

- Location 1 – Carrick-on-Shannon landfill in Ballynamoney: the site consists of a mound approximately 6.0m to 7.0m above the existing road level. Gas ventilation pipes were noted at the top of the mound. Drainage is in place at the base of the slope on the Keadew side.

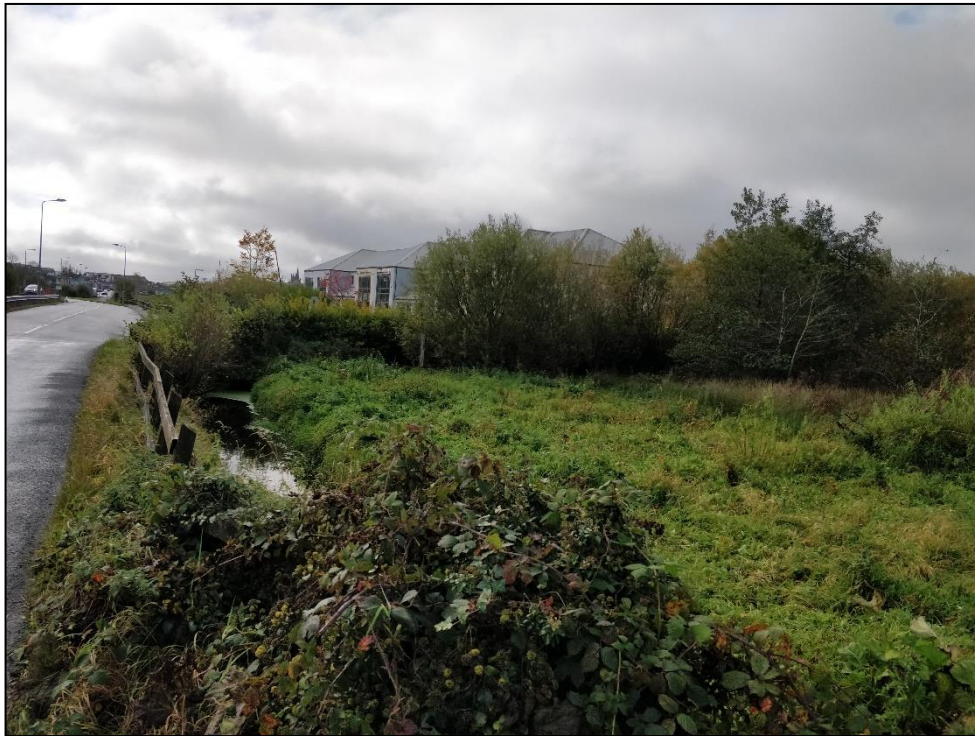
### L1.1 Looking southwest

- Location 2 – Waste permit site registered to a Mr. Brian Kenny north of Carrick-on-Shannon: the site is approximately 1.0m lower than the existing road level and the land rises towards the north of the site. Ground conditions were observed as marshy, wet ground with a drainage ditch running through the middle. A stream was also noted running parallel to the road.

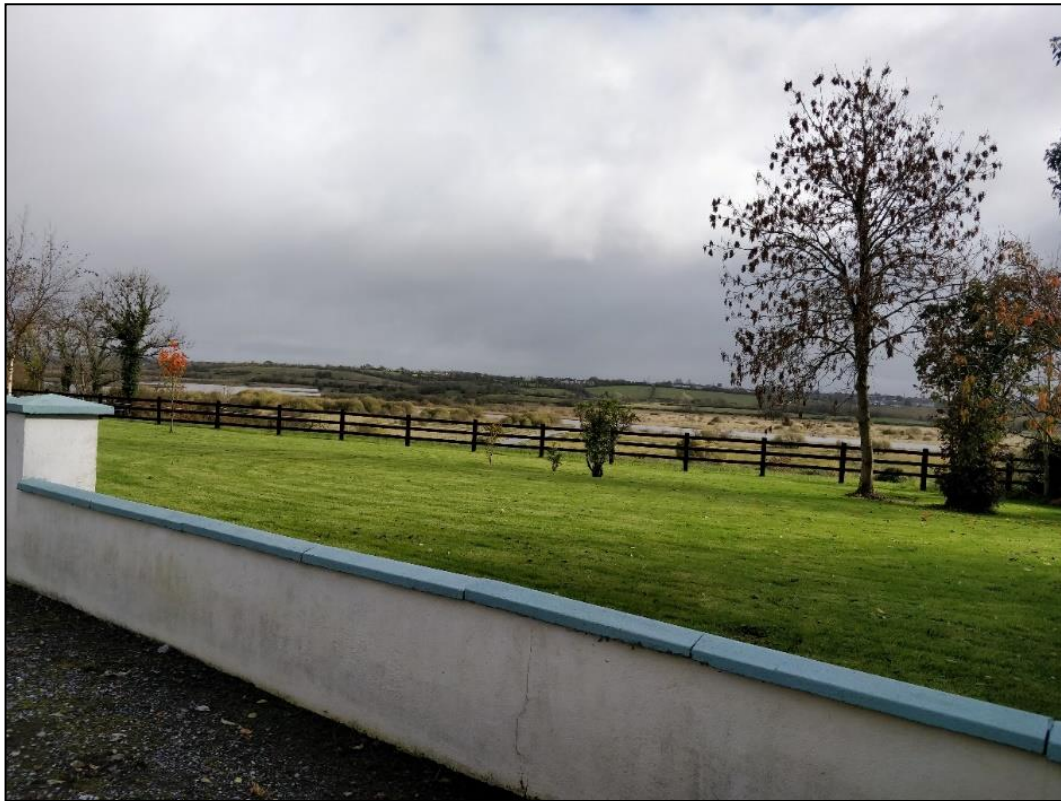
L5.1 Looking east from the public road on the western side of the River Shannon. The higher ground in the foreground is dry but the ground gets wet and marshy on the floodplain

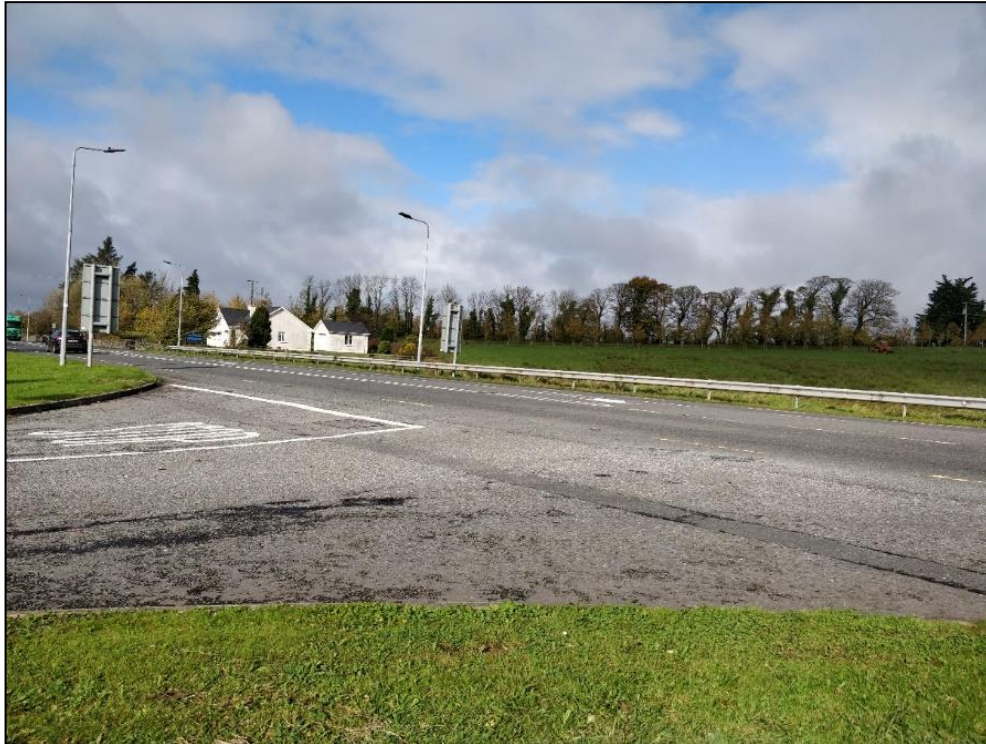
- Location 7 – An area of alluvium intersecting the existing N4 approximately 0.5km west of Carrick-on-Shannon: Soft ground observed on the eastern side of the N4. The ground level on the western side is approximately 2m below the existing N4. There are reeds and rushes present indicating the ground is wet.

L7.1 Photograph taken on the existing N4 looking northeast

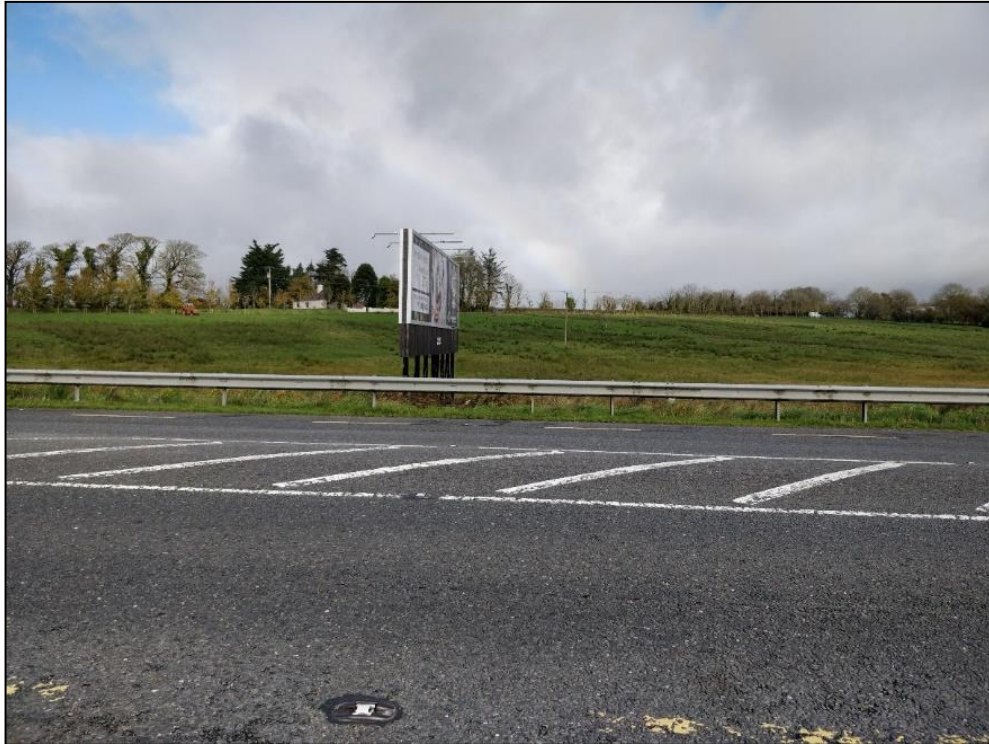
L7.2 Photograph taken on the existing N4 looking east

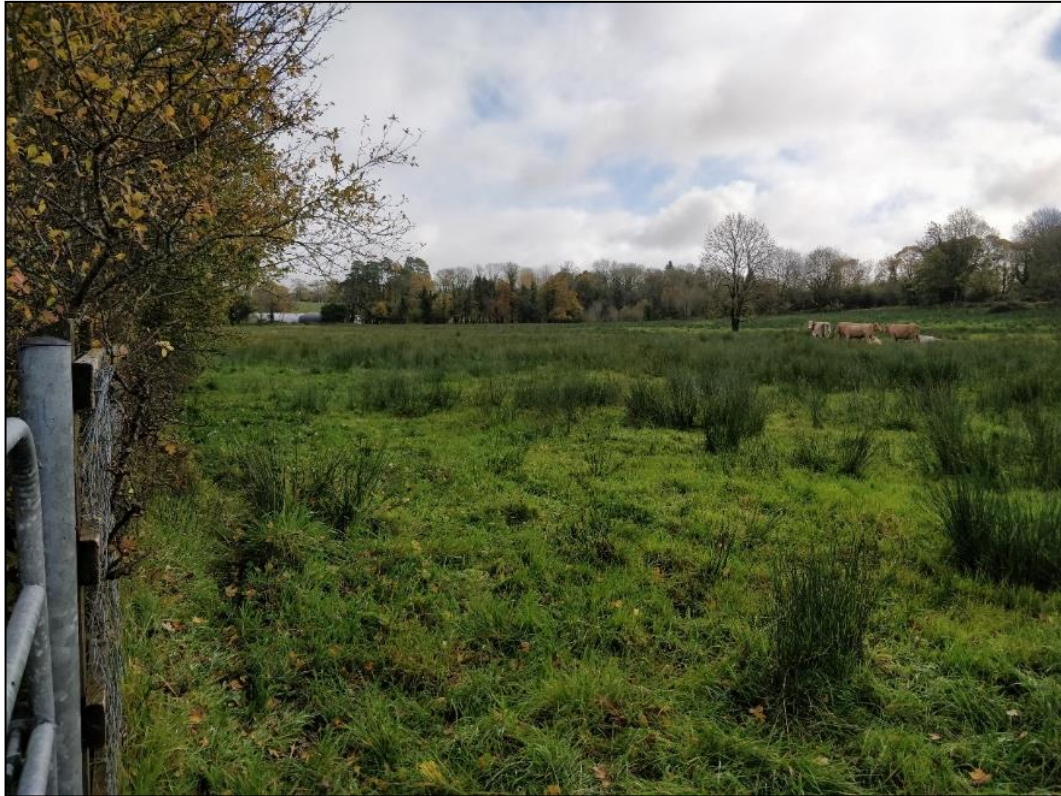
- Locations 8 and 9 – A historic waste permit site in the Cloongownagh Townland along the existing N4, approximately 2.5km west of Carrick-on-Shannon: It appears that the ground increases in elevation at the location of the old waste permit site on the western side of the N4. The waste permit site no longer appears active and is covered over. Reeds and rushes were noted in this area.

L8.1 Photograph taken in lands to the right-hand side (western side) of the existing N4

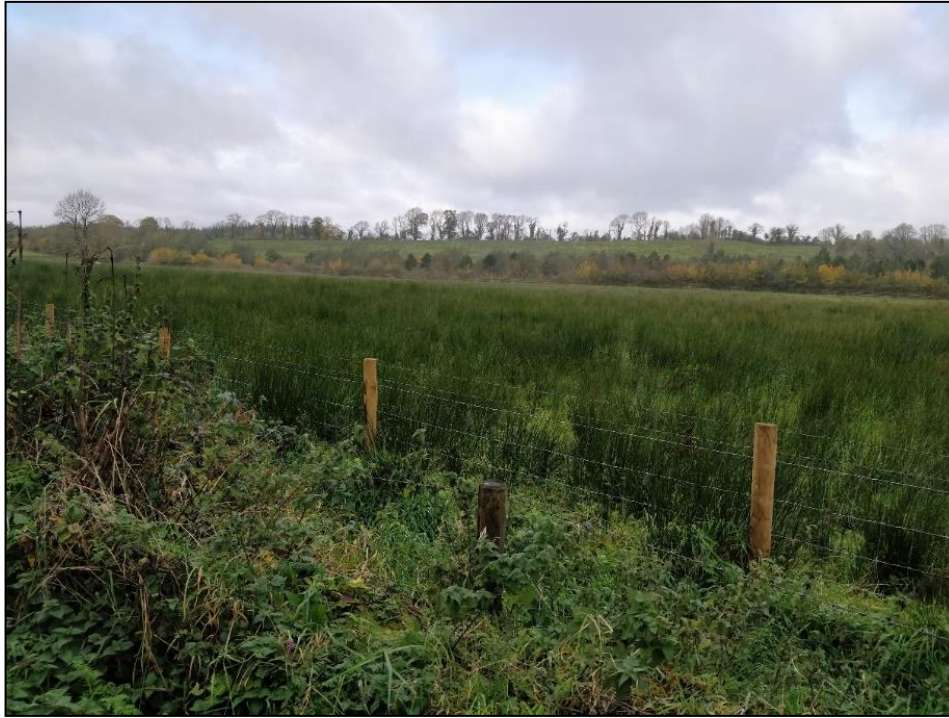
L9.1 Photograph taken on the southern side of the waste permitted site looking north

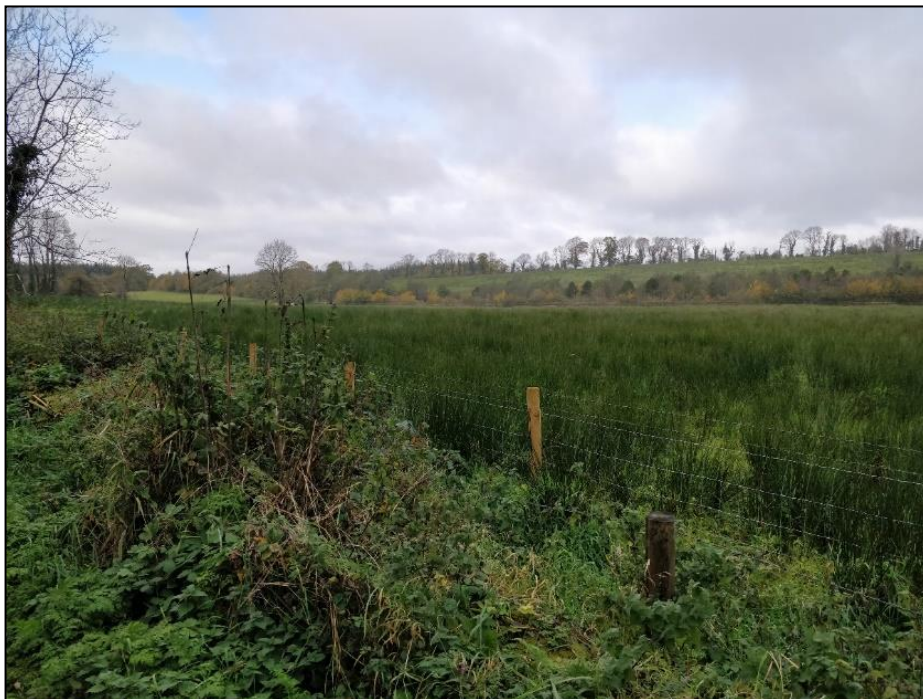
L9.2 Photograph taken on the southern side of the waste permitted site looking north

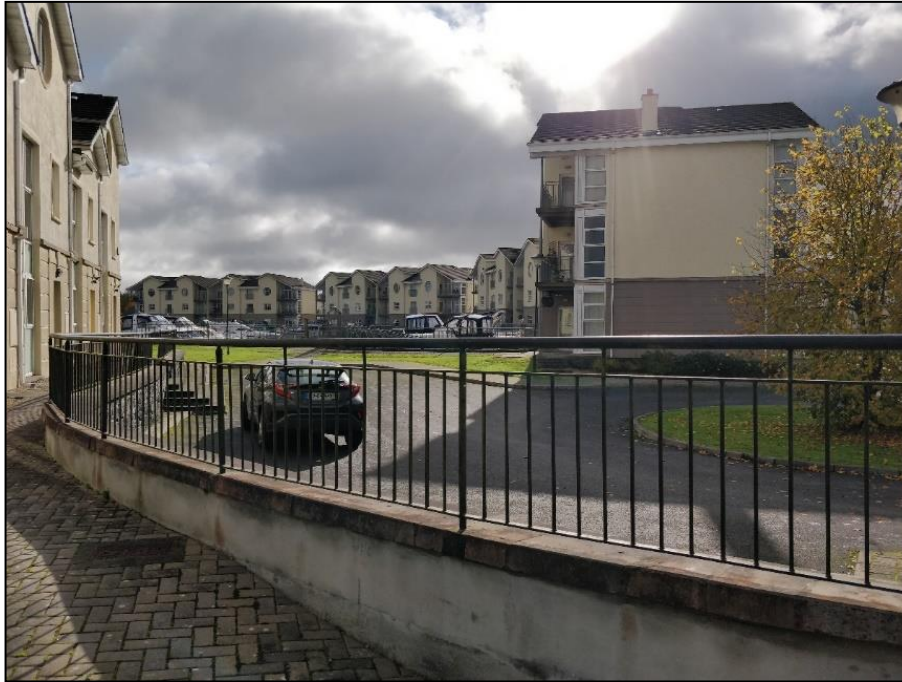
- Location 10 – A historic waste permit site and area of soft ground (peat) just west of Carrick-on-Shannon in the Drishoge Townland: This site seems to be partially redeveloped into apartments to the south and a commercial building to the west adjacent to the existing road. The site is on the floodplain of the River Shannon. Existing ground conditions are wet, marshy with access possible on foot only. The waste permit site is no longer active and appears to be covered over.

L10.1 Photograph taken in the apartment development looking south

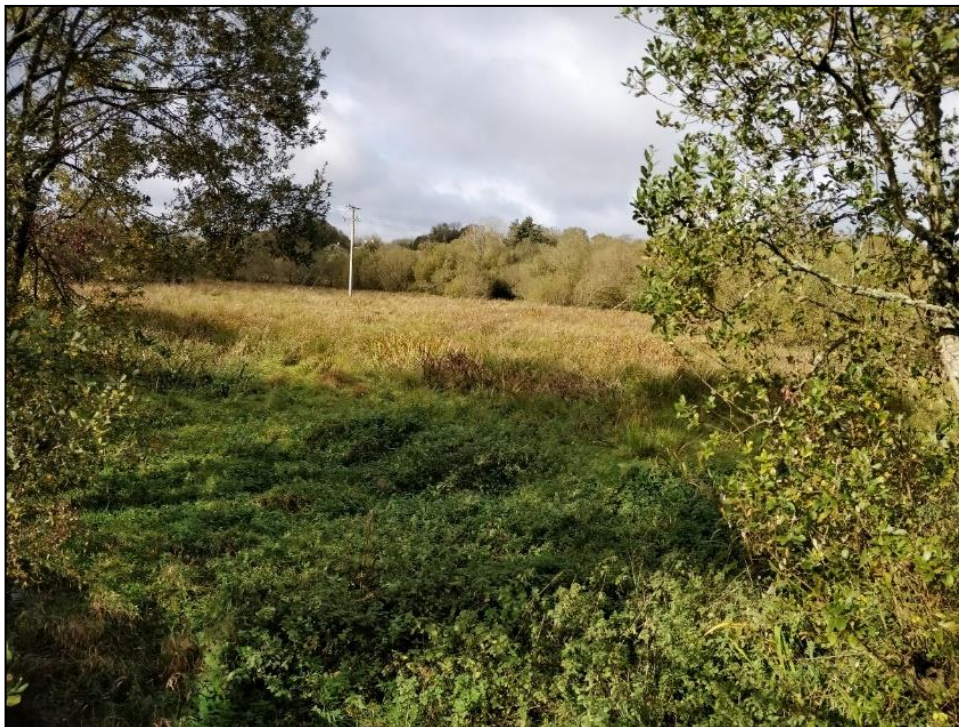
L10.2 Lands to the north of the apartment development that are also within the waste permitted site

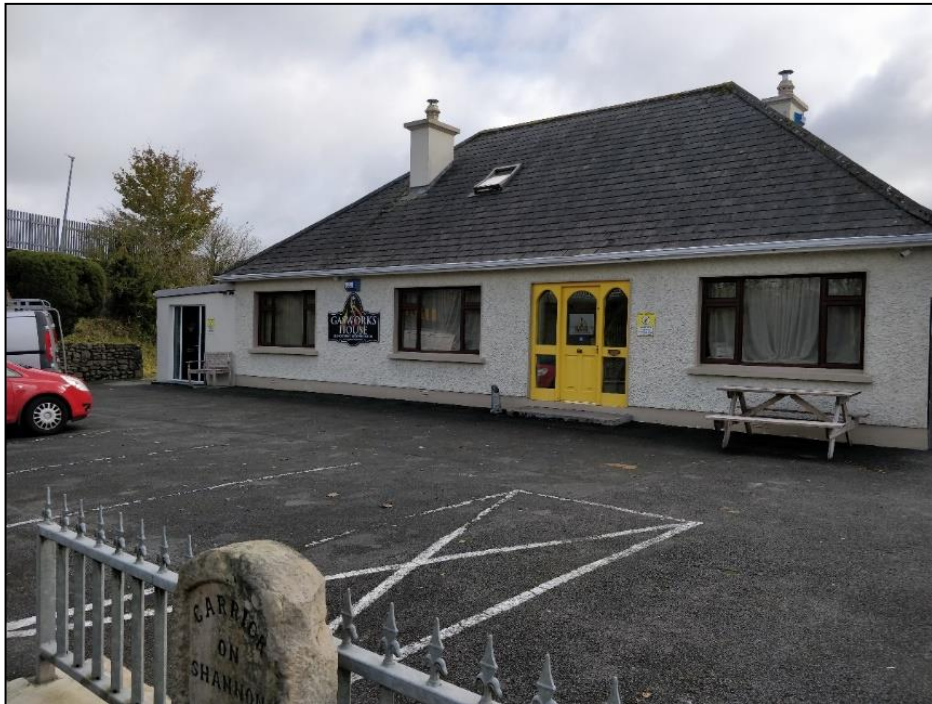
- Location 11 – A historic gas works site located on the western side of Carrick-on-Shannon near the Carrick-on-Shannon station: The site of the former gas works has been replaced with a commercial building, there is no evidence of the former gas works. The railway line that passes adjacent to this site is on a 3.0m high embankment. The topography rises to the north and south, therefore the embankment is short in length. To the southeastern side of the railway embankment, there is a green area that might be a suitable location to undertake GI.

L11.1 Site of the old gasworks building

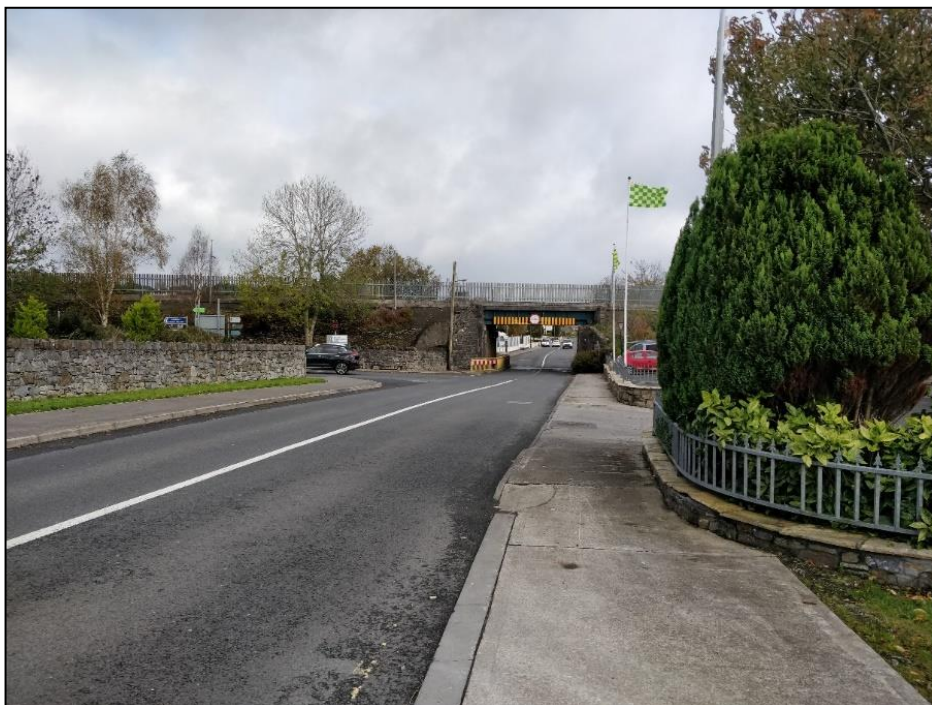
L11.2 Photo taken on the R368 facing towards Carrick-on-Shannon. Railway embankment shown in the background. The site of the old gasworks building is on the right of the photograph.

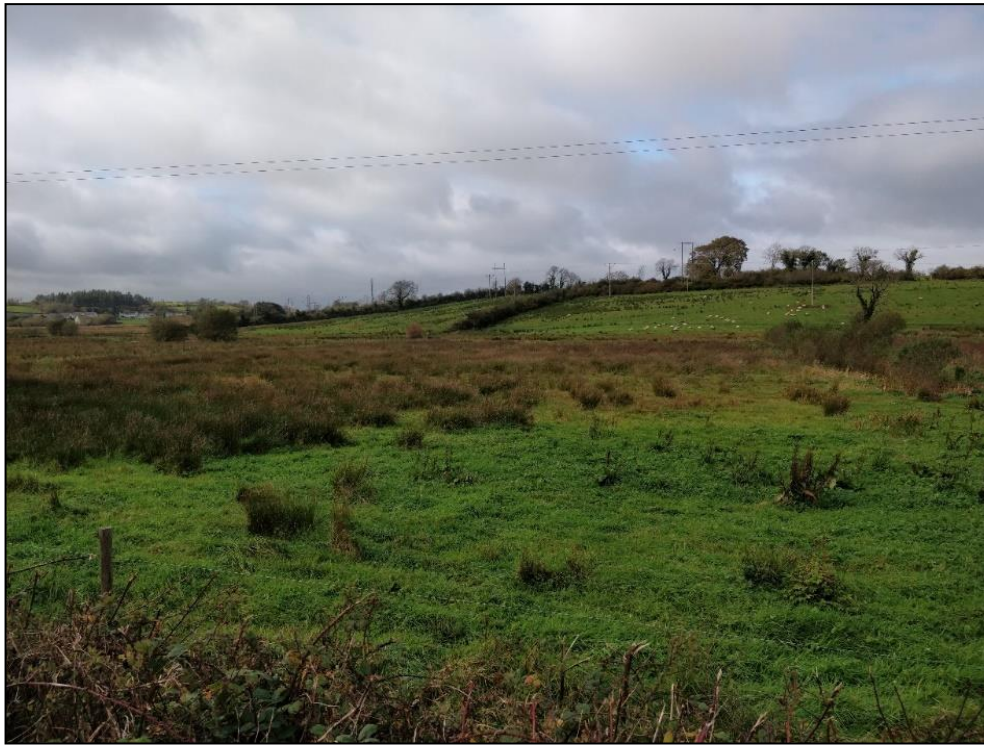
- Location 12 – An area of peat south of Carrick-on-Shannon along the western banks of the River Shannon: The site of this soft ground peat deposit is in a natural west to east trending valley with the ground rising towards the north and south. A stream/river runs along the alignment of this valley and outfalls to the River Shannon to the east. The ground conditions are wet, marshy and very soft.

L12.1 Lands to the south of Killukin River running parallel to the local road that accesses the camping ground. Photograph taken on the local road looking north.

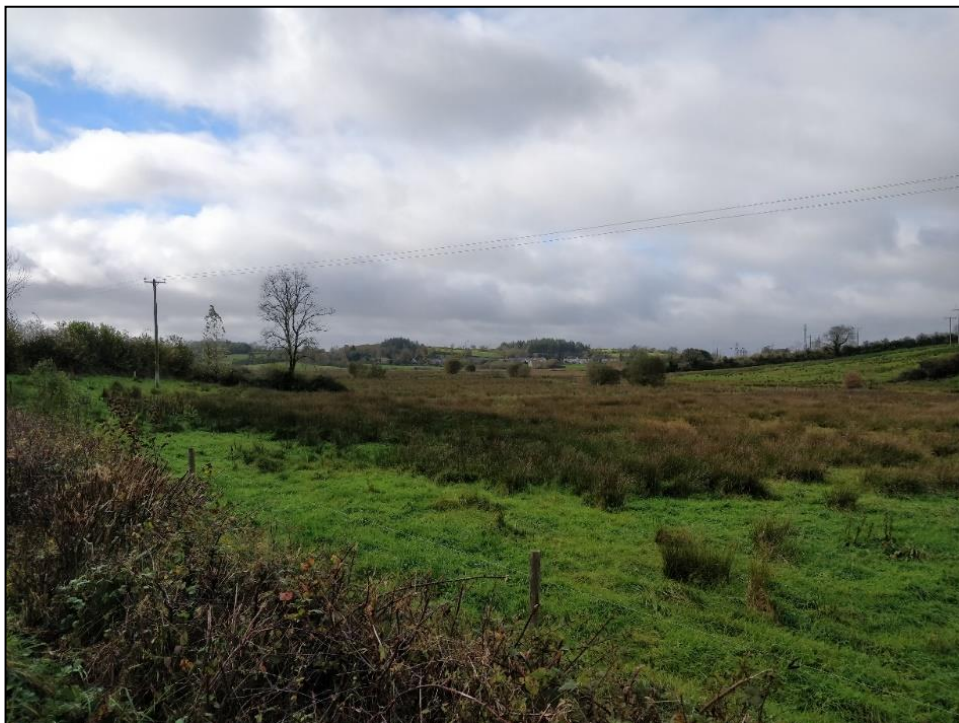
L12.2 Lands to the south of Killukin River running parallel to the local road that accesses the camping ground. Photograph taken on the local road looking west.

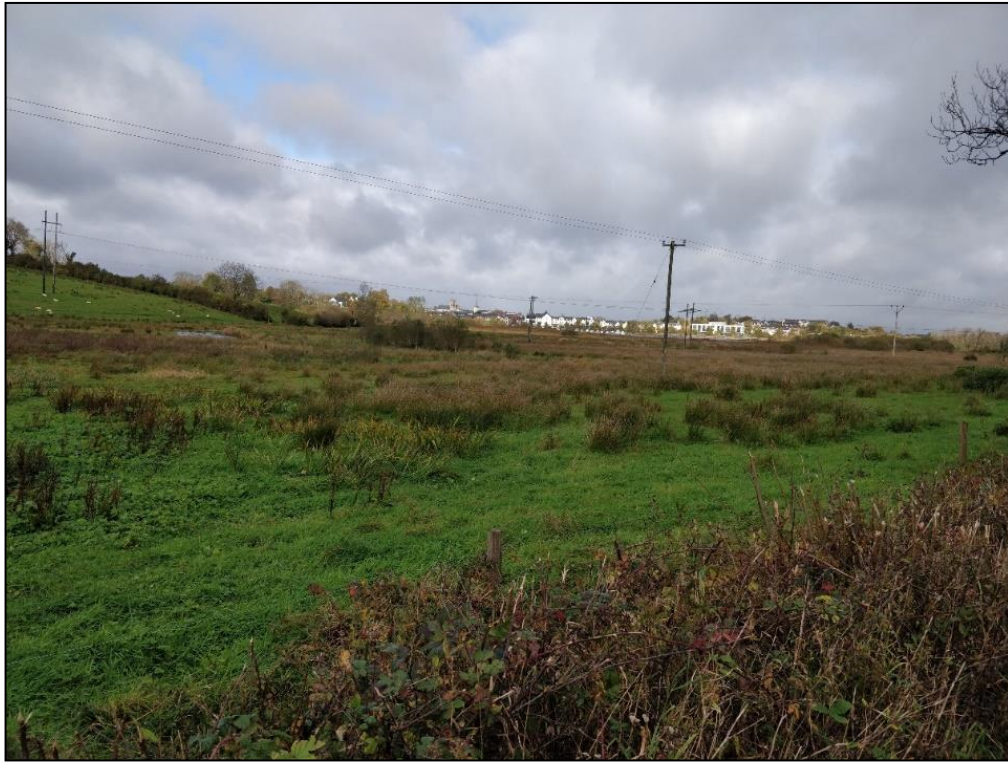
L12.3 Lands to the south of Killukin River running parallel to the local road that accesses the camping ground. Photograph taken on the local road looking northeast.

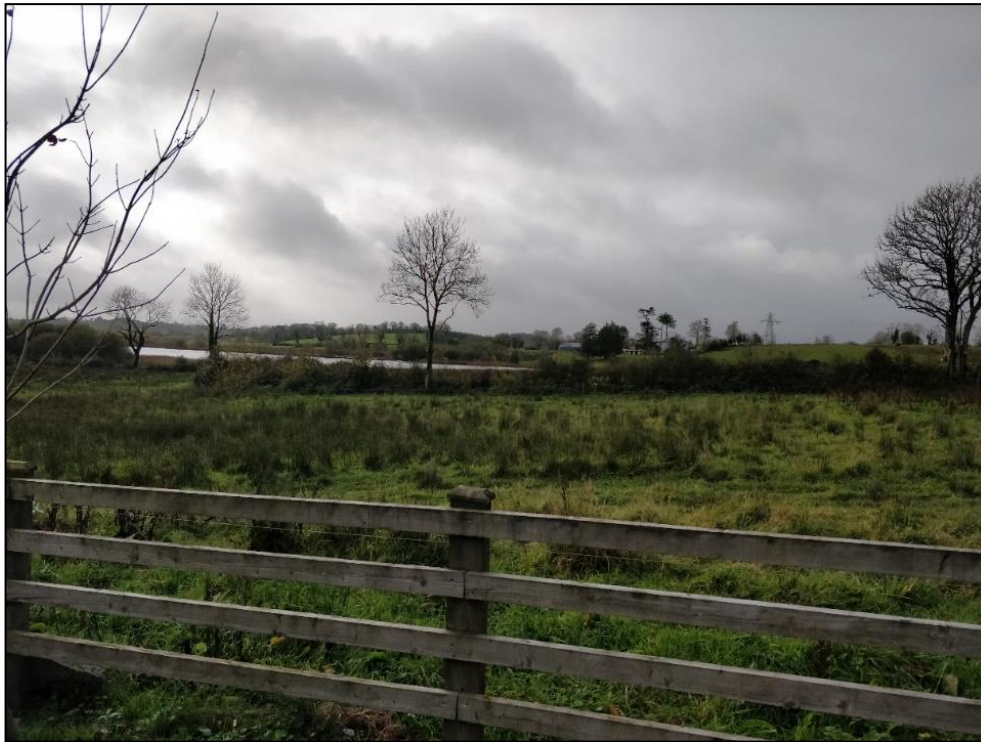
- Location 14 – Potential alternative River Shannon crossing south of Carrick-on-Shannon (eastern side of river): better ground conditions in the field immediately south of the housing estate Glas na hAbhainn. There is a substation at the western end of the development. From this point onwards the ground conditions become poor towards the River Shannon. The low ground > 200m south of the estate was flooded during the site visit.

L14.1 Photograph taken looking north from the riverside end of the Glas na hAbhainn estate on the eastern side of the River Shannon.

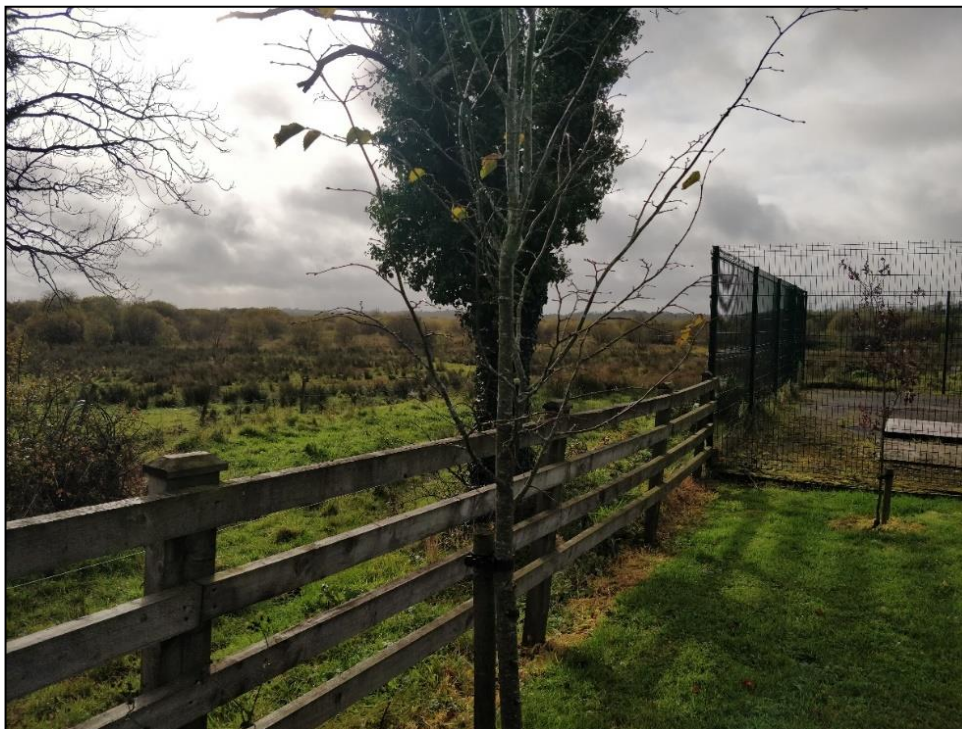
L14.2 Photograph taken looking west at the riverside end of Glas na hAbhainn estate.

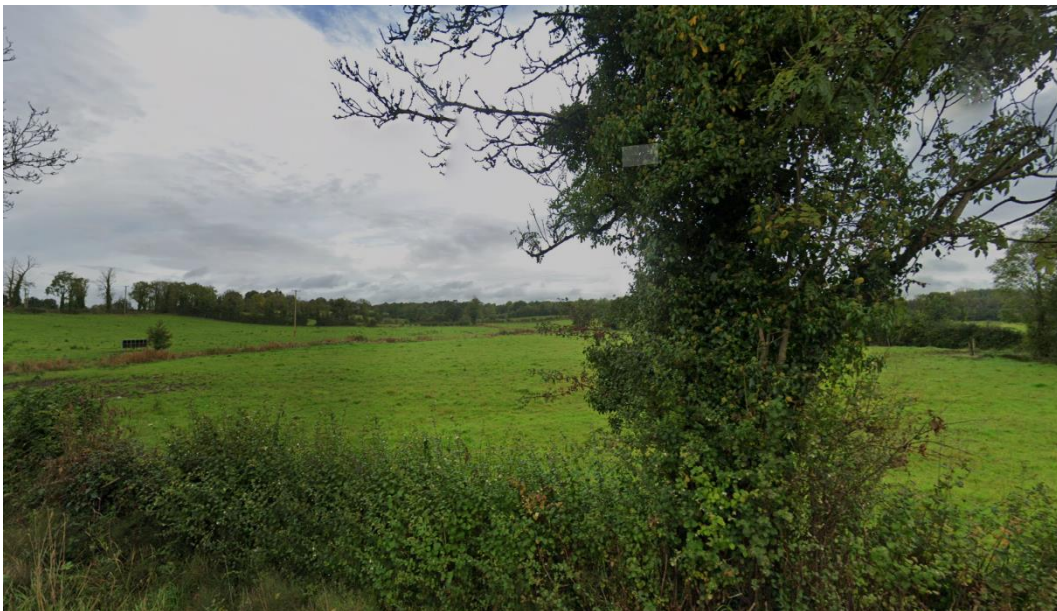
L19.1 Photograph taken looking south. No obvious evidence of a historic pit or quarry at this location.

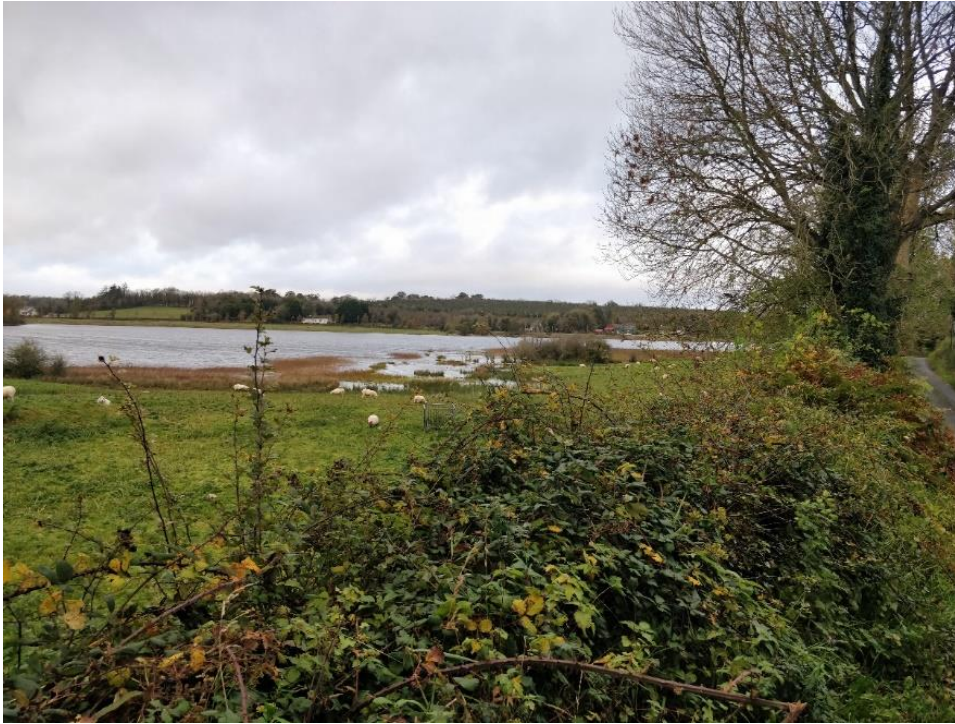
- Location 19 –(19A) The N4 piled embankment adjacent to the Drumgilra Lough: The ground either side of this 2m high embankment is noted by Arup during the site survey as being populated by reeds and rushes which indicates that the ground may be waterlogged. A drive by survey was only possible at this location. (19B) This location also captured the historic pit and quarry that is to the east of the N4. There was no evidence of a pit or quarry at this location.

L20.1 Photograph was taken on the southern side of Drumgilra Lough looking northeast.

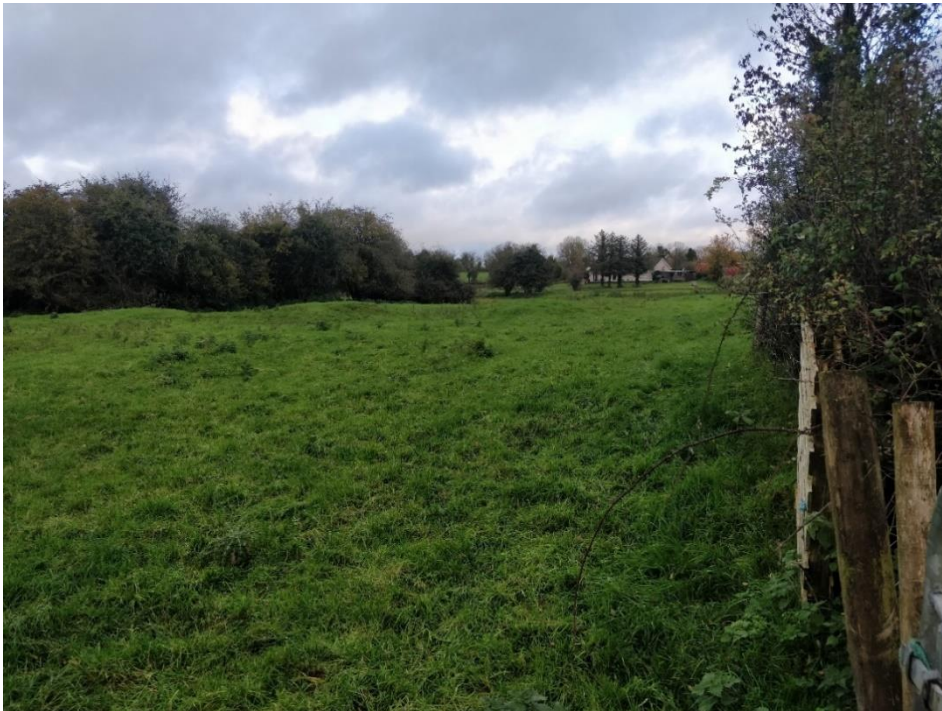
L20.2 Photograph was taken on the southern side of Drumgilra Lough looking northeast. This photograph was taken closer to the existing N4 than the photograph in L20.1.
